City of Taunton, MA
2017 Pump Station Inspection Report

2017 Pump Station Inspection Report

City of Taunton, MA

Prepared by: BETA GROUP, INC.
Prepared for: City of Taunton Department of Public Works

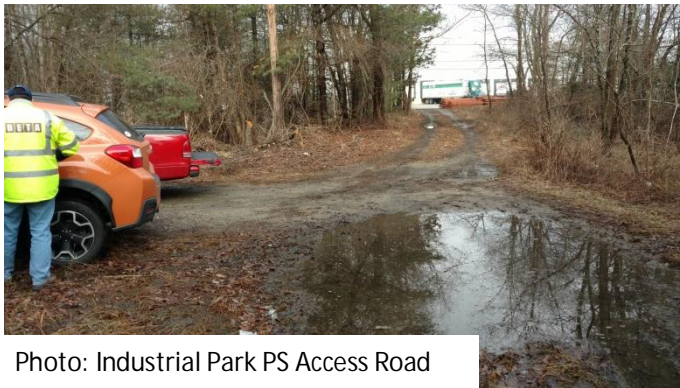
Each station was evaluated for site conditions, including site access, pavement, landscaping, fencing, and security. In general, access to pumping stations was in reasonable condition during inspections. Fences are present at all but one station (South St), and generally are in good condition. All fence gates are padlocked for security. In general, site conditions at stations across the City were very good. Access to Industrial Park and the Red Lane Pumping Station, alternately known as "East Taunton", were exceptions. Both stations are at the end of unimproved roadways and access in dry conditions is marginal. However, during wet conditions or winter weather, access to both stations is a challenge. The Red Lane station in particular is in a remote area and subject to regular vandalism as evidenced by a dilapidated fence, dents/holes in the door from gun projectiles and spray paint on the face of the building that had recently been repainted by Veolia.

Photo: Industrial Park PS Access Road

Generator is 30+ years old (original to station)	Replace generator	Open
Industrial Park	Access driveway is dirt in poor condition	Pave Driveway	Open
	Drywell concrete is spalling badly	Repair Concrete	Open
	Suction and discharge pipe and valves is rusty	Paint or replace pipe	Scheduled (Veolia, 2017)
	Pumps are 25 years old, and pump #1 has already been rebuilt (2015).	Replace Pumps	Open
	Drywell heater does not work	Heater is unnecessary - remove heater	Open
	Drywell has no dehumidifier and needs one	Install Dehumidifier	Installed (Veolia, 3/8/17)
King James	Pump motors have been replaced (2009&2011), but pumps are almost 30 years old	Replace Pumps	Open
	Discharge pipe and valves are in poor condition	Replace pipe and valves	Open
	Drywell unit heater does not work	Heater is unnecessary - remove heater	Open
	Station houses a portable generator that powers this and several other stations. At the time of inspection the generator was not generating sufficient voltage to power station.	Repair or replace generator	Repaired (Veolia, 1/24/17)

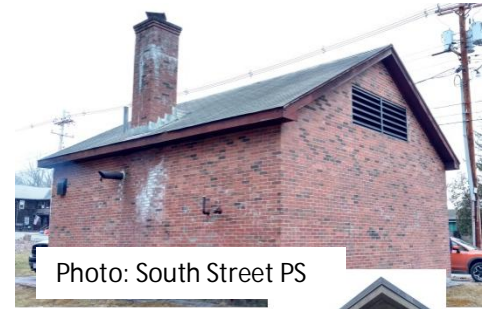
Minor architectural issues, such as rusted hatch/door operators and hinges, and limited exterior water staining were identified at each of the buildings. The building with the most severe water damage was at the South Street pumping station. Moisture has penetrated the brick at the chimney and the south facing wall and started to separate from the wall.

Photo: South Street PS

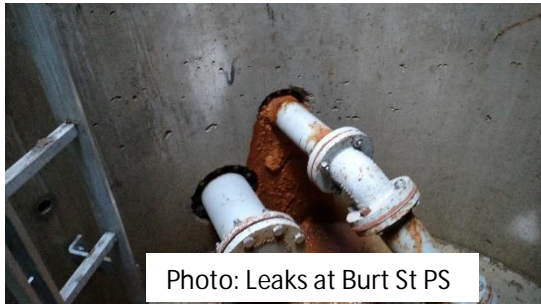
Structural inspections covered buildings, where present, and also concrete structures such as wet wells, dry wells, and valve vaults. In general, stations are in good structural shape, with a few exceptions. Industrial Park PS showed some spalling of concrete, and infiltration was noted at Colt Circle, Burt St, and Hart St.

Photo: Leaks at Burt St PS

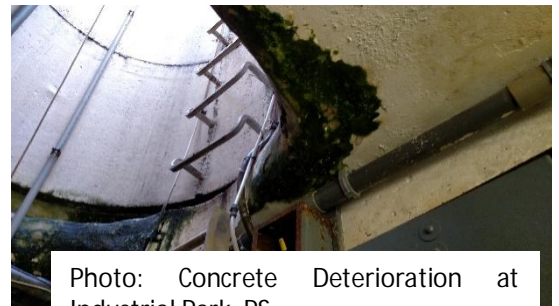
Photo: Concrete Deterioration at Industrial Park PS

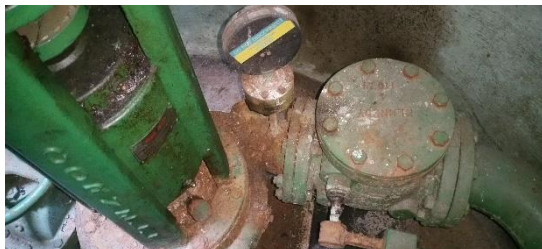
Photo: Leaking pump at Myles Standish PS

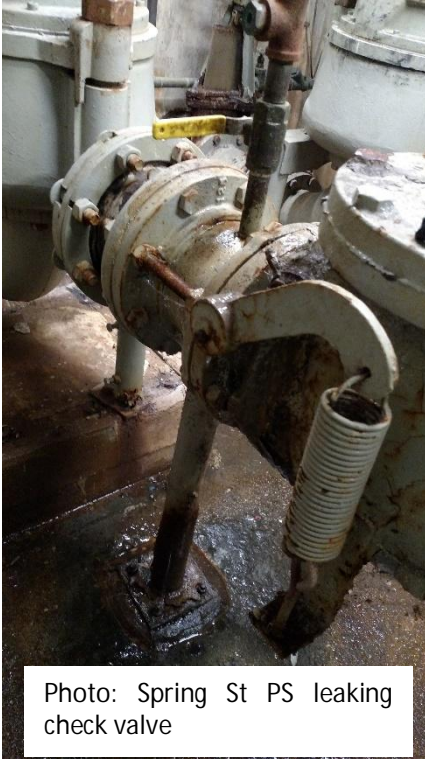
Photo: Spring St PS leaking check valve

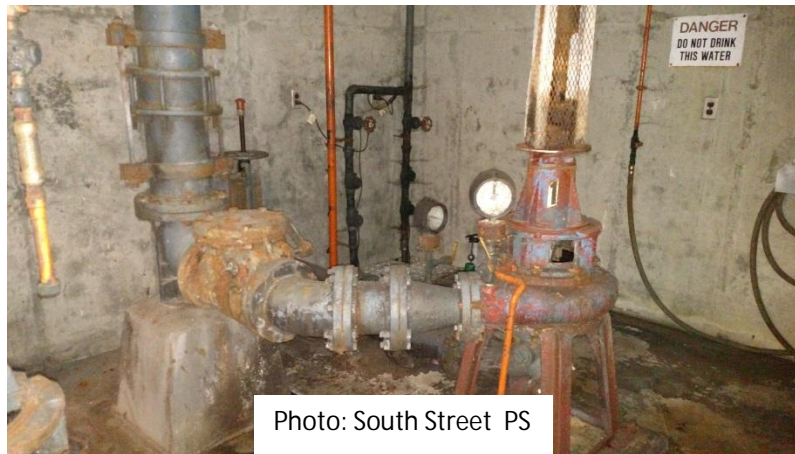
Photo: South Street PS

In older stations, piping and valves in dry pits and in valve vaults of submersible stations was often found to be in need of paint and piping exhibited evidence of rust. Isolation gate, plug, and check valves are not exercised regularly and have corrosion in most locations. In many locations, suction and/or discharge shutoff valves are not functional and are leaking in several stations. While this does not affect the day-to-day operation of the station, in an emergency it is critical that these valves be operable for pump repair or replacement operations.

South Street	Pumps are very old (30+ years) and have had multiple major repairs recently	Replace Pumps	Open
	Discharge piping and valves rusty, leaks at valves and pumps	Replace pipe and valves	Open
	Louvers do not open on power fail for generator	Repair Louvers	Scheduled (Veolia, 2017)
South Walker Street	Discharge plug valves cannot be turned	Exercise or replace valves	Scheduled (Veolia, 2017)
Spring Street	Building louvers are not functional and/or blocked	Repair/unblock louvers	Repaired (Veolia, 2017)
	Roof is broken in one spot	Repair Roof	Scheduled (Veolia, 2017)
	Pumps are 40+ years old and are beyond design life	Replace Pumps	Open
	Discharge piping and valves are very old/rusty	Paint or replace pipe and valves	Scheduled (Veolia, 2017)
	Level control – bubbler tube freezes in cold weather, is currently housed in insulated box with light bulb for heat	Replace or relocate level control	Open
	Generator is 40+ years old and is very loud	Replace generator	Open

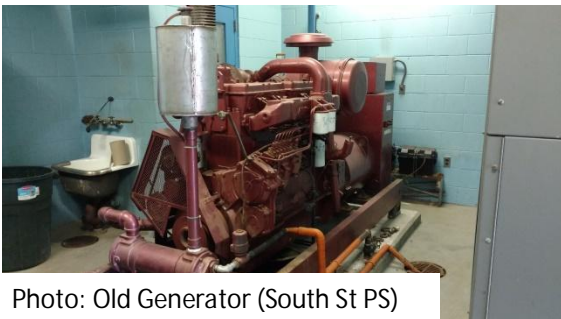
Photo: Old Generator (South St PS)

Based on these observations, there are two recommendations. First, a more comprehensive testing protocol should be instituted, where generators are regularly tested under load, and transfer switches are confirmed to work properly. In accordance with TR-16, such tests should be performed twice per year. Second, a review of all generators city-wide should be done, and a determination made on which ones should be replaced, and if any additional generators (and/or automatic transfer capacity) should be provided to stations which do not currently have them.

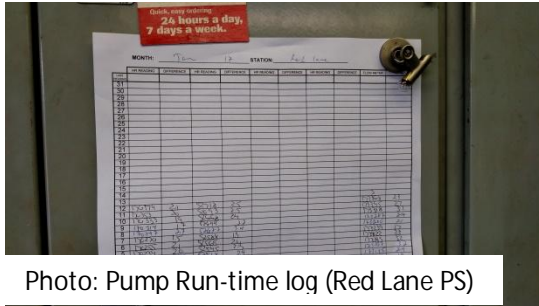
Photo: Pump Run-time log (Red Lane PS)

recommended that each station have its own Operation and Maintenance Manual , and that a running log of maintenance activities be kept as part of the manual.
