# Flow Assessment Services, LLC. Structure Inspection Log

Municipality:	Hull, MA	Manhole No.:	20696
Street:	40 Whitehead Avenue	Sub-System:	4
Inspection Date:	4/29/2020	Inspector:	MA
		Map #:

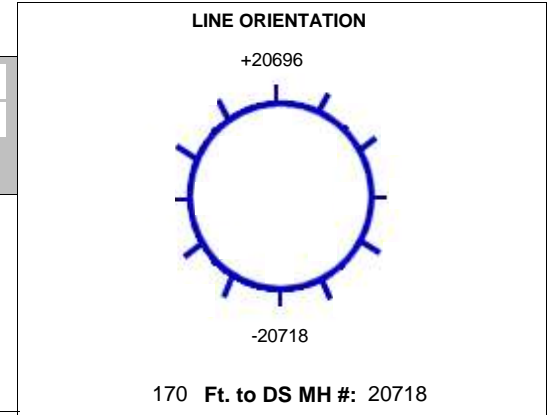
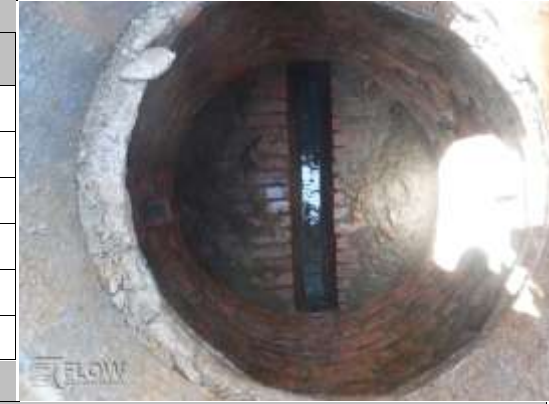
Cracked pavement surrounding frame

ITEM	MATERIAL	CONDITION	Leaks (gpm)	DEFECTS
FRAME	CAST	1		
CORBEL	BRICK	1		
STEPS	BRICK	1		
WALLS	PRECAST	3	0.1	Weeping infiltration
FLOOR	BRICK	2		Missing mortar
INVERT	BRICK	1

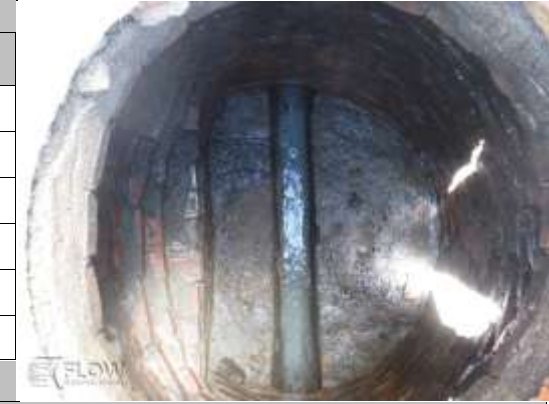
Cracked pavement surrounding frame

ITEM	MATERIAL	CONDITION	Leaks (gpm)	DEFECTS
FRAME	CAST	1		
CORBEL	BRICK	3	0.1	Missing mortar, Weeping infiltration
STEPS	NONE	0		
WALLS	BRICK	3		Weeping infiltration
FLOOR	BRICK	1		
INVERT	BRICK	1

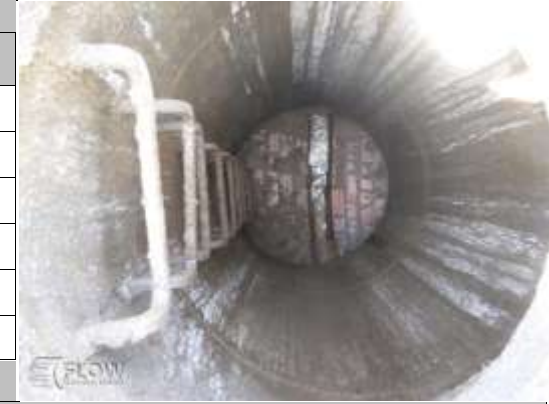
Cracked and missing pavement surrounding frame

ITEM	MATERIAL	CONDITION	Leaks (gpm)	DEFECTS
FRAME	CAST	1		
CORBEL	BRICK	2		Missing mortar
STEPS	ALUM	1		
WALLS	PRECAST	1		
FLOOR	BRICK	1		
INVERT	BRICK	4	0.25	Running infiltration at incoming pipe

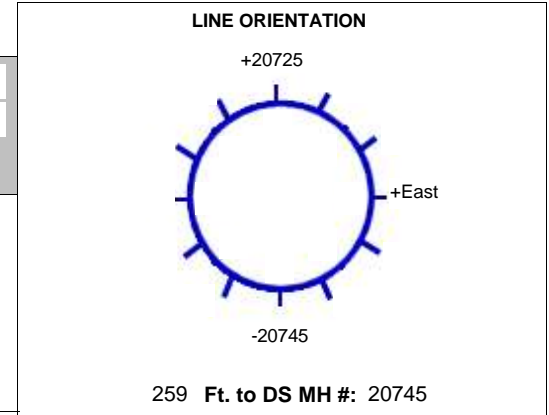
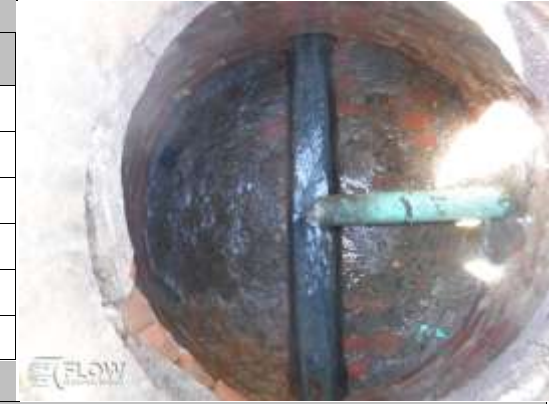
Cracked pavement surrounding frame

ITEM	MATERIAL	CONDITION	Leaks (gpm)	DEFECTS
FRAME	CAST	1		
CORBEL	BRICK	2		Missing mortar
STEPS	BRICK	1		
WALLS	BRICK	1		
FLOOR	BRICK	4	0.25	Running infiltration
INVERT	PARGED	1

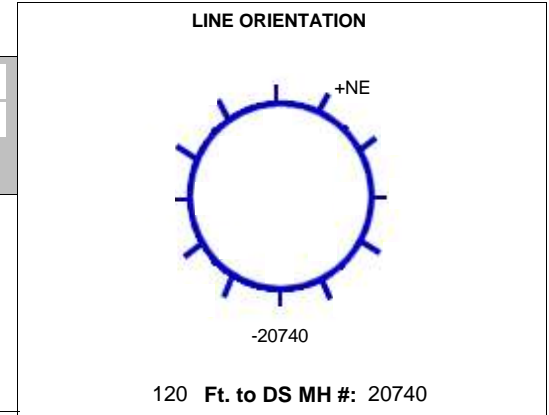
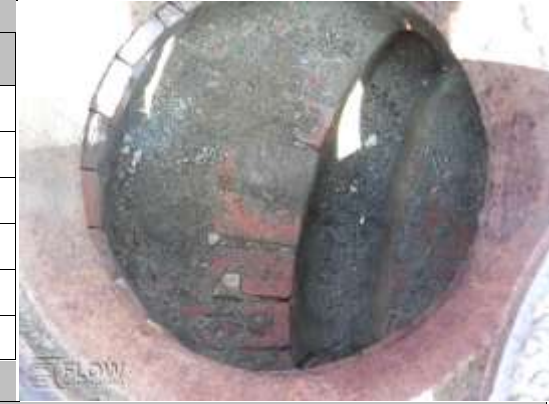
Cracked pavement surrounding frame

ITEM	MATERIAL	CONDITION	Leaks (gpm)	DEFECTS
FRAME	CAST	1		
CORBEL	BRICK	2		Missing mortar
STEPS	NONE	0		
WALLS	BRICK	1		
FLOOR	BRICK	2		Missing mortar
INVERT	BRICK	1

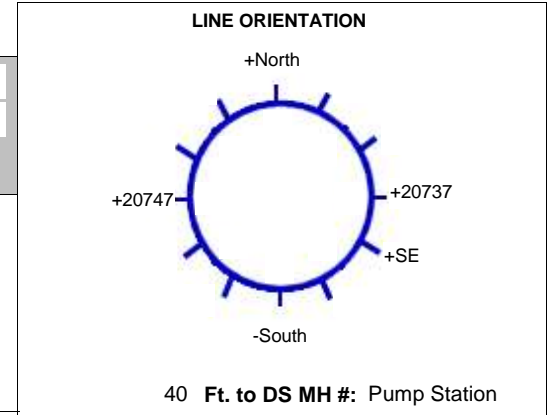
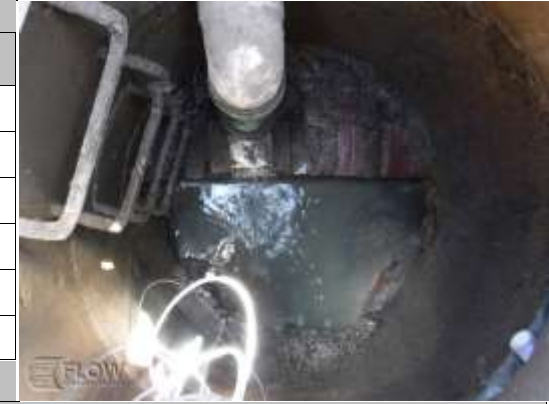
ITEM	MATERIAL	CONDITION	Leaks (gpm)	DEFECTS
FRAME	CAST	1		
CORBEL	BRICK	1		
STEPS	ALUM	1		
WALLS	PRECAST	4	0.25	Running infiltration at inlet #3
FLOOR	BRICK	1		
INVERT	BRICK	1

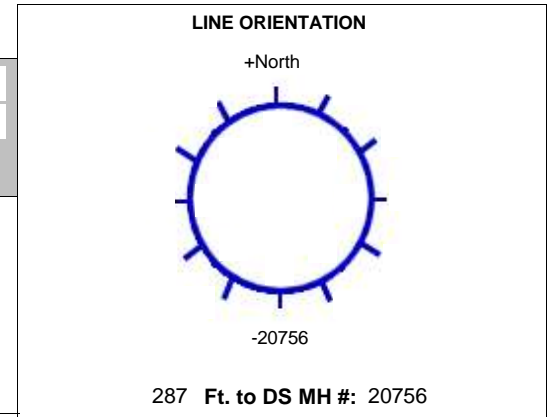
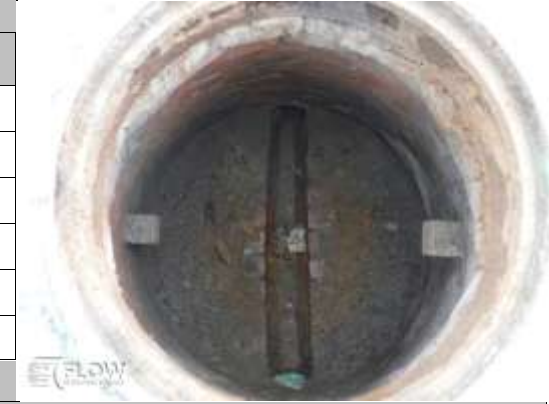
Cracked pavement surrounding frame

ITEM	MATERIAL	CONDITION	Leaks (gpm)	DEFECTS
FRAME	CAST	1		
CORBEL	BRICK	1		
STEPS	BRICK	1		
WALLS	BRICK	1		
FLOOR	BRICK	1		
INVERT	BRICK	2		Missing mortar

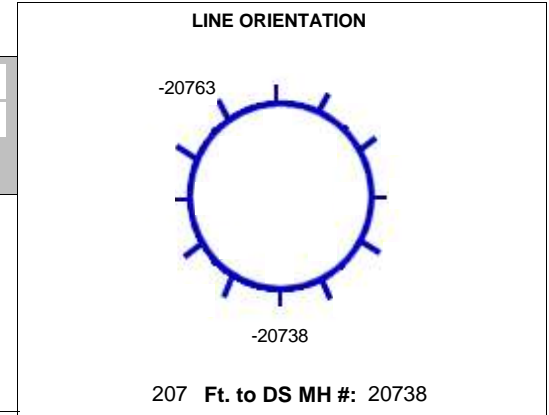
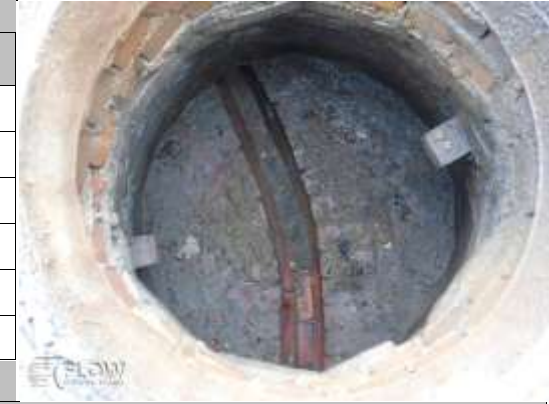
Cracked and missing pavement surrounding frame

ITEM	MATERIAL	CONDITION	Leaks (gpm)	DEFECTS
FRAME	CAST	2		Chipped
CORBEL	BRICK	1		
STEPS	BRICK	1		
WALLS	BRICK	1		
FLOOR	BRICK	1		
INVERT	BRICK	1

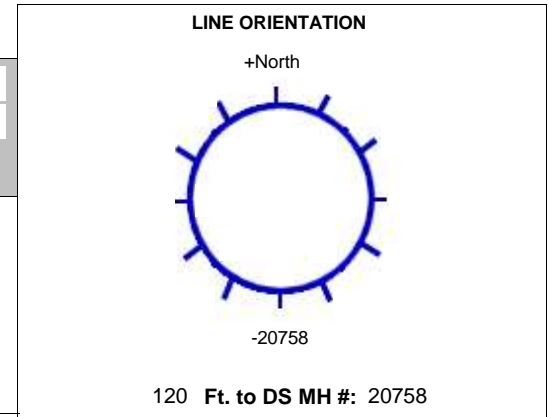
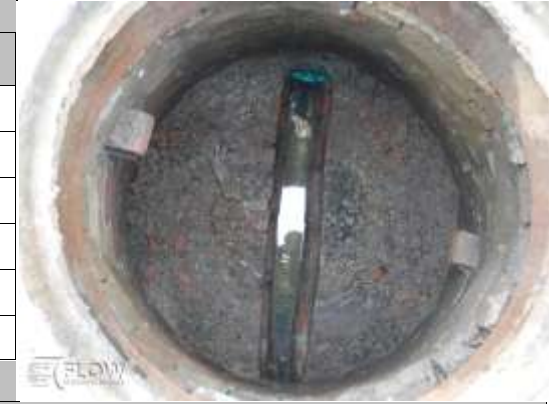
Cracked pavement surrounding frame

ITEM	MATERIAL	CONDITION	Leaks (gpm)	DEFECTS
FRAME	CAST	1		
CORBEL	BRICK	2		Deteriorating brick
STEPS	BRICK	1		
WALLS	BRICK	1		
FLOOR	BRICK	1		
INVERT	BRICK	1
