Inspection Report for North Sturbridge Road Solar Facility

NPDES ID No.: MAR10031G

Inspection Date: 7/29/2022

PHOTOGRAPHIC DOCUMENTATION  
North Sturbridge Road Solar Facility  
Charlton, Massachusetts  
Photographs Documented 7.29.2022

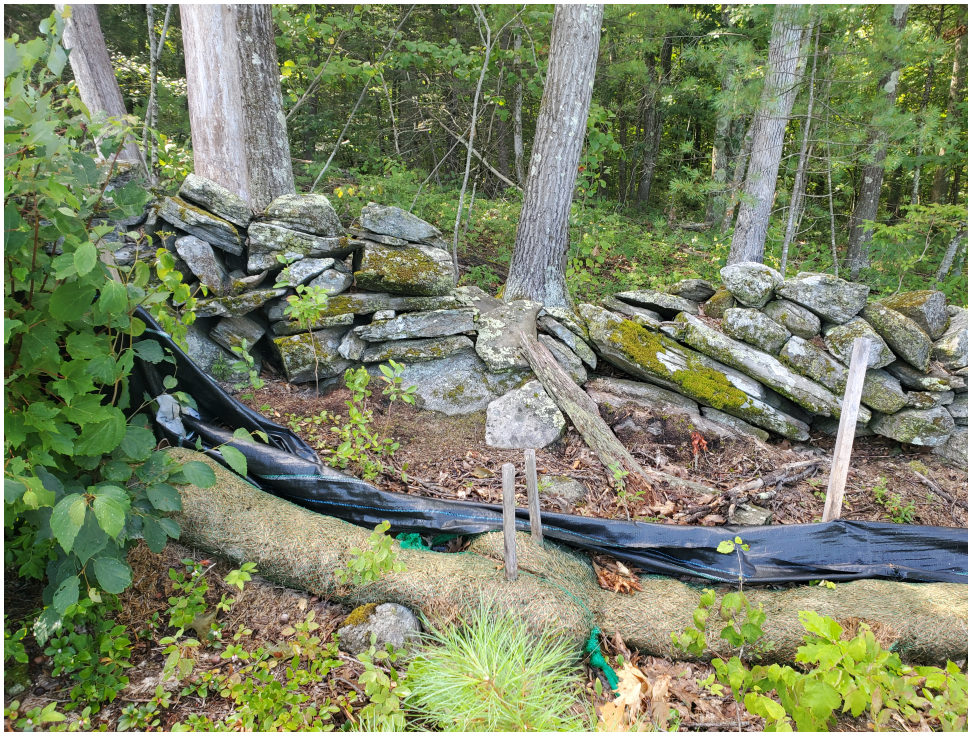
Photo 1

View of damaged silt fence in northeastern portion of the Site — facing east

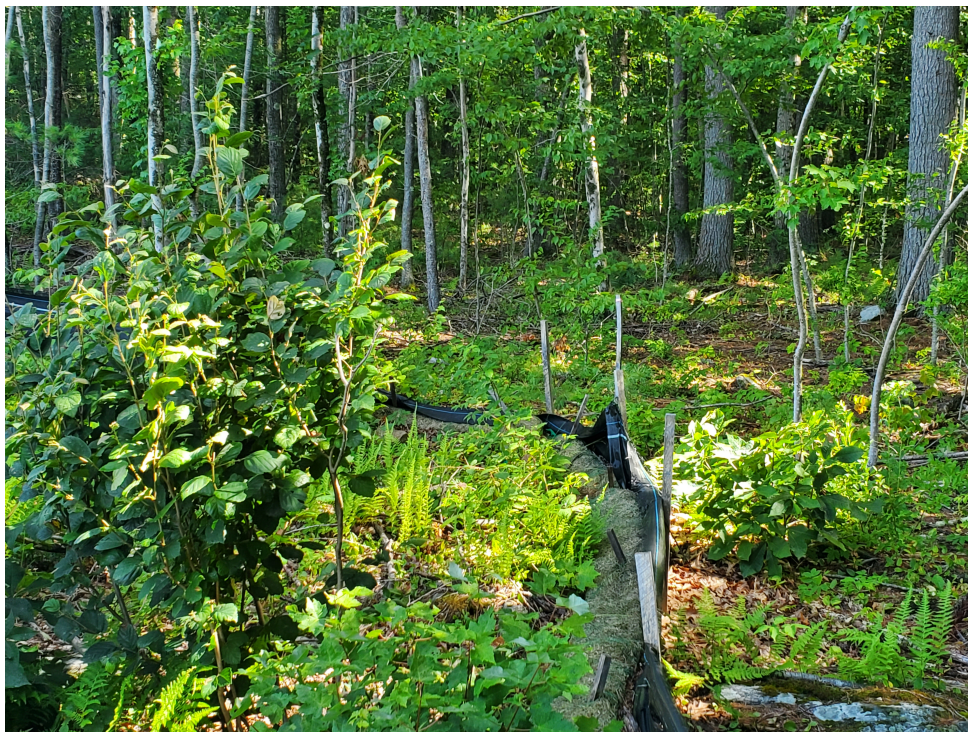
Photo 2

View of damaged silt fence in northeast portion of the Site — facing northeast

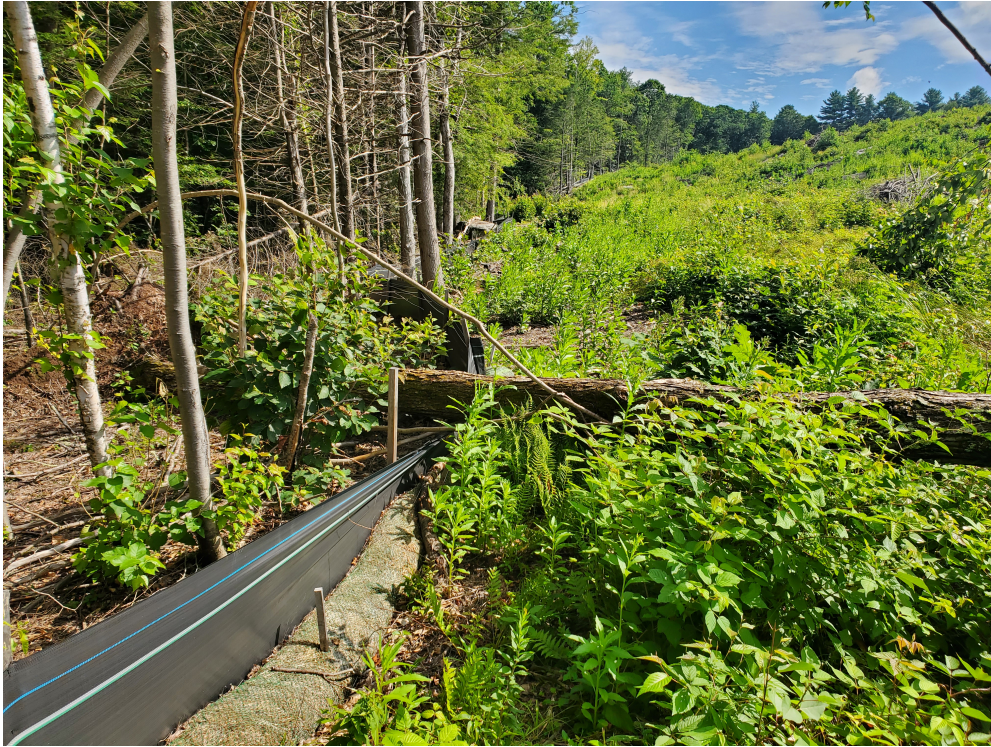
Photo 3

Type/Location of E&S Control	Maintenance Needed?*	Corrective Action Required?*	Date on Which Maintenance or Corrective Action First Identified?	Notes
1. Silt Fence and Straw Wattles	Yes	No	3/15/2022	On 7/29/2022 BETA observed fallen tree damage to the silt fence on the western perimeter of the Site, damage was first observed on 6/20/2022  On 7/29/2022 BETA observed damage to the wattles in the north-east and eastern corners of the Site, damage was first observed on 3/15/2022. BETA also observed the silt fence to be partly torn in the southeastern corner of the Site, damage was first observed on 3/27/2022. General maintenance is needed for the entire silt fence. No evidence of discharge was observed.

View of fallen tree damage to silt fence in southwestern portion of the Site — facing north

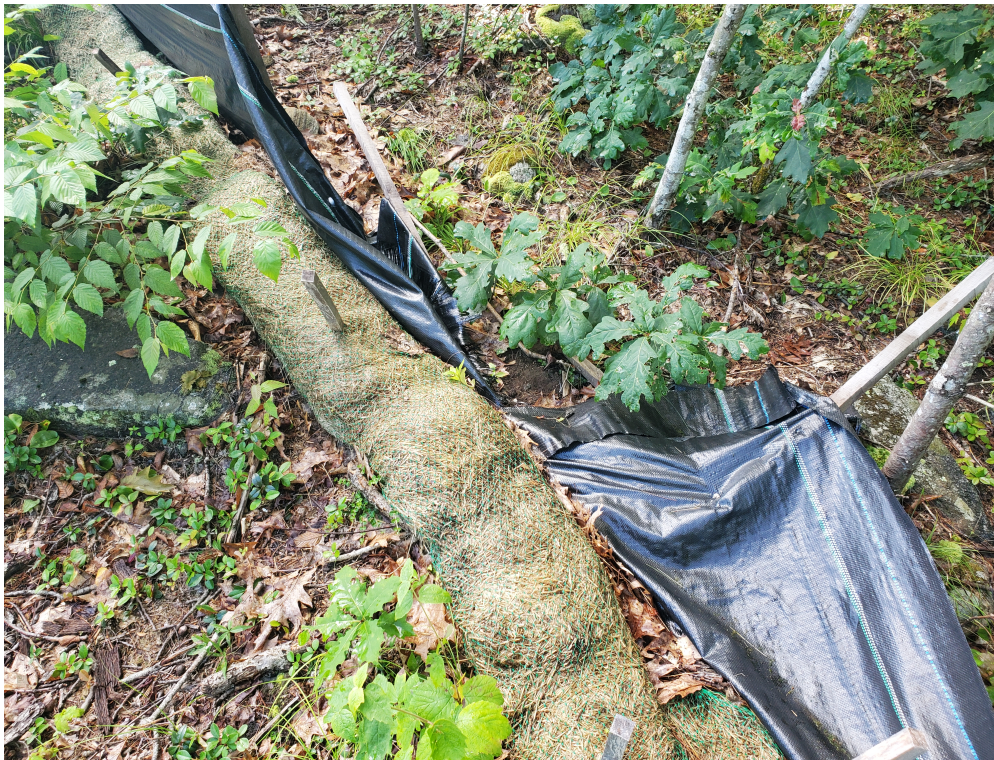
Photo 4

View of damaged silt fence in southeastern portion of the Site — facing northeast
