CAPE COD  
COMMISSION

## Route 6 Hydroplaning Crash Analysis and Alternatives Development

Bourne, Sandwich, Barnstable, Yarmouth,  
Dennis, Harwich, Brewster and Orleans

October 2013

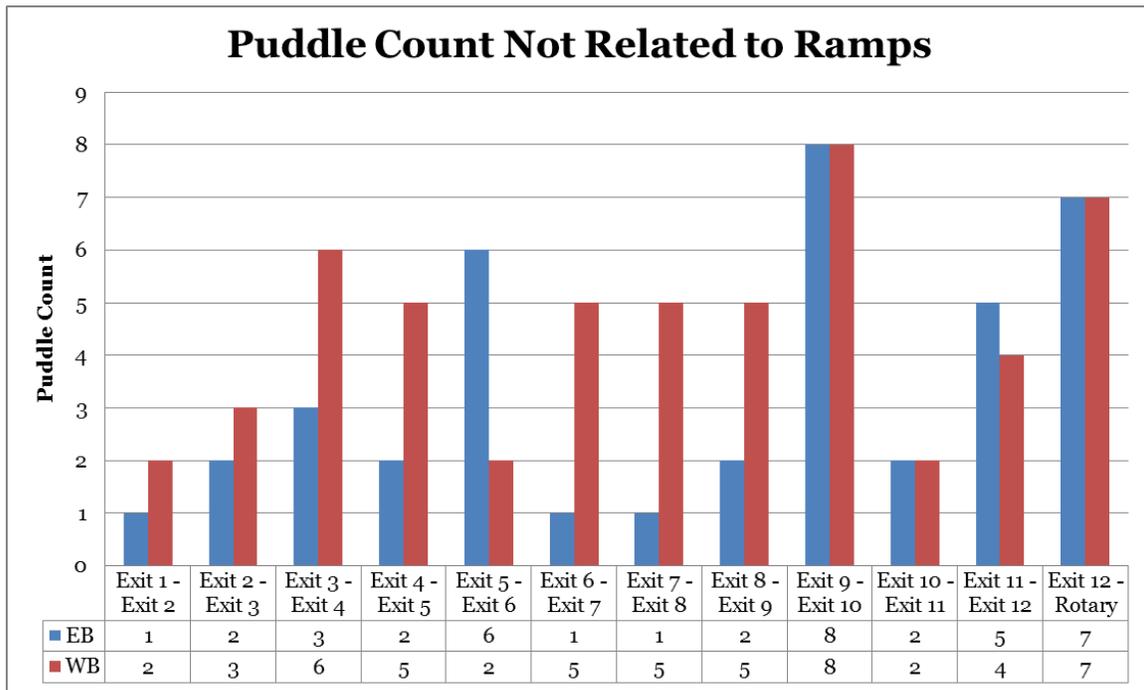
FIGURE 5: PUDDLE COUNT DURING RESEARCH STUDY PERIOD (JUNE – AUGUST, 2013)

To further investigate locations where hydroplaning may be resulting in unsafe locations, a field investigation of ponding conditions during rain events was conducted during the summer of 2013. The intent of this “puddle inventory” was to identify locations where there may or may not be a documented crash history, where ponding is resulting in conditions that could result in hydroplaning incidents. A complete description of puddle inventory methodology is provided in Appendix B of this report. The degree to which ponding is present in the roadway is a function of both the duration and the depth of rain that falls in a specific period of time, also referred to as intensity. The puddle inventory covered rain events varying in both duration and intensity. Overall, the puddle inventory was developed during rain events that resulted in 0.6 to 2.8 inches over a 24 hr. period of storm event. Figure 5 and Figure 6 present a summary of results for the puddle inventory considering the eastbound and westbound direction of Route 6 between each exit.
