#### Inspection Report for North Sturbridge Road Solar Facility NPDES ID No.: MAR10031G Inspection Date: 09/02/2021

PHOTOGRAPHIC DOCUMENTATION North Sturbridge Road Solar Facility Charlton, Massachusetts Photographs Documented 09.02.2021

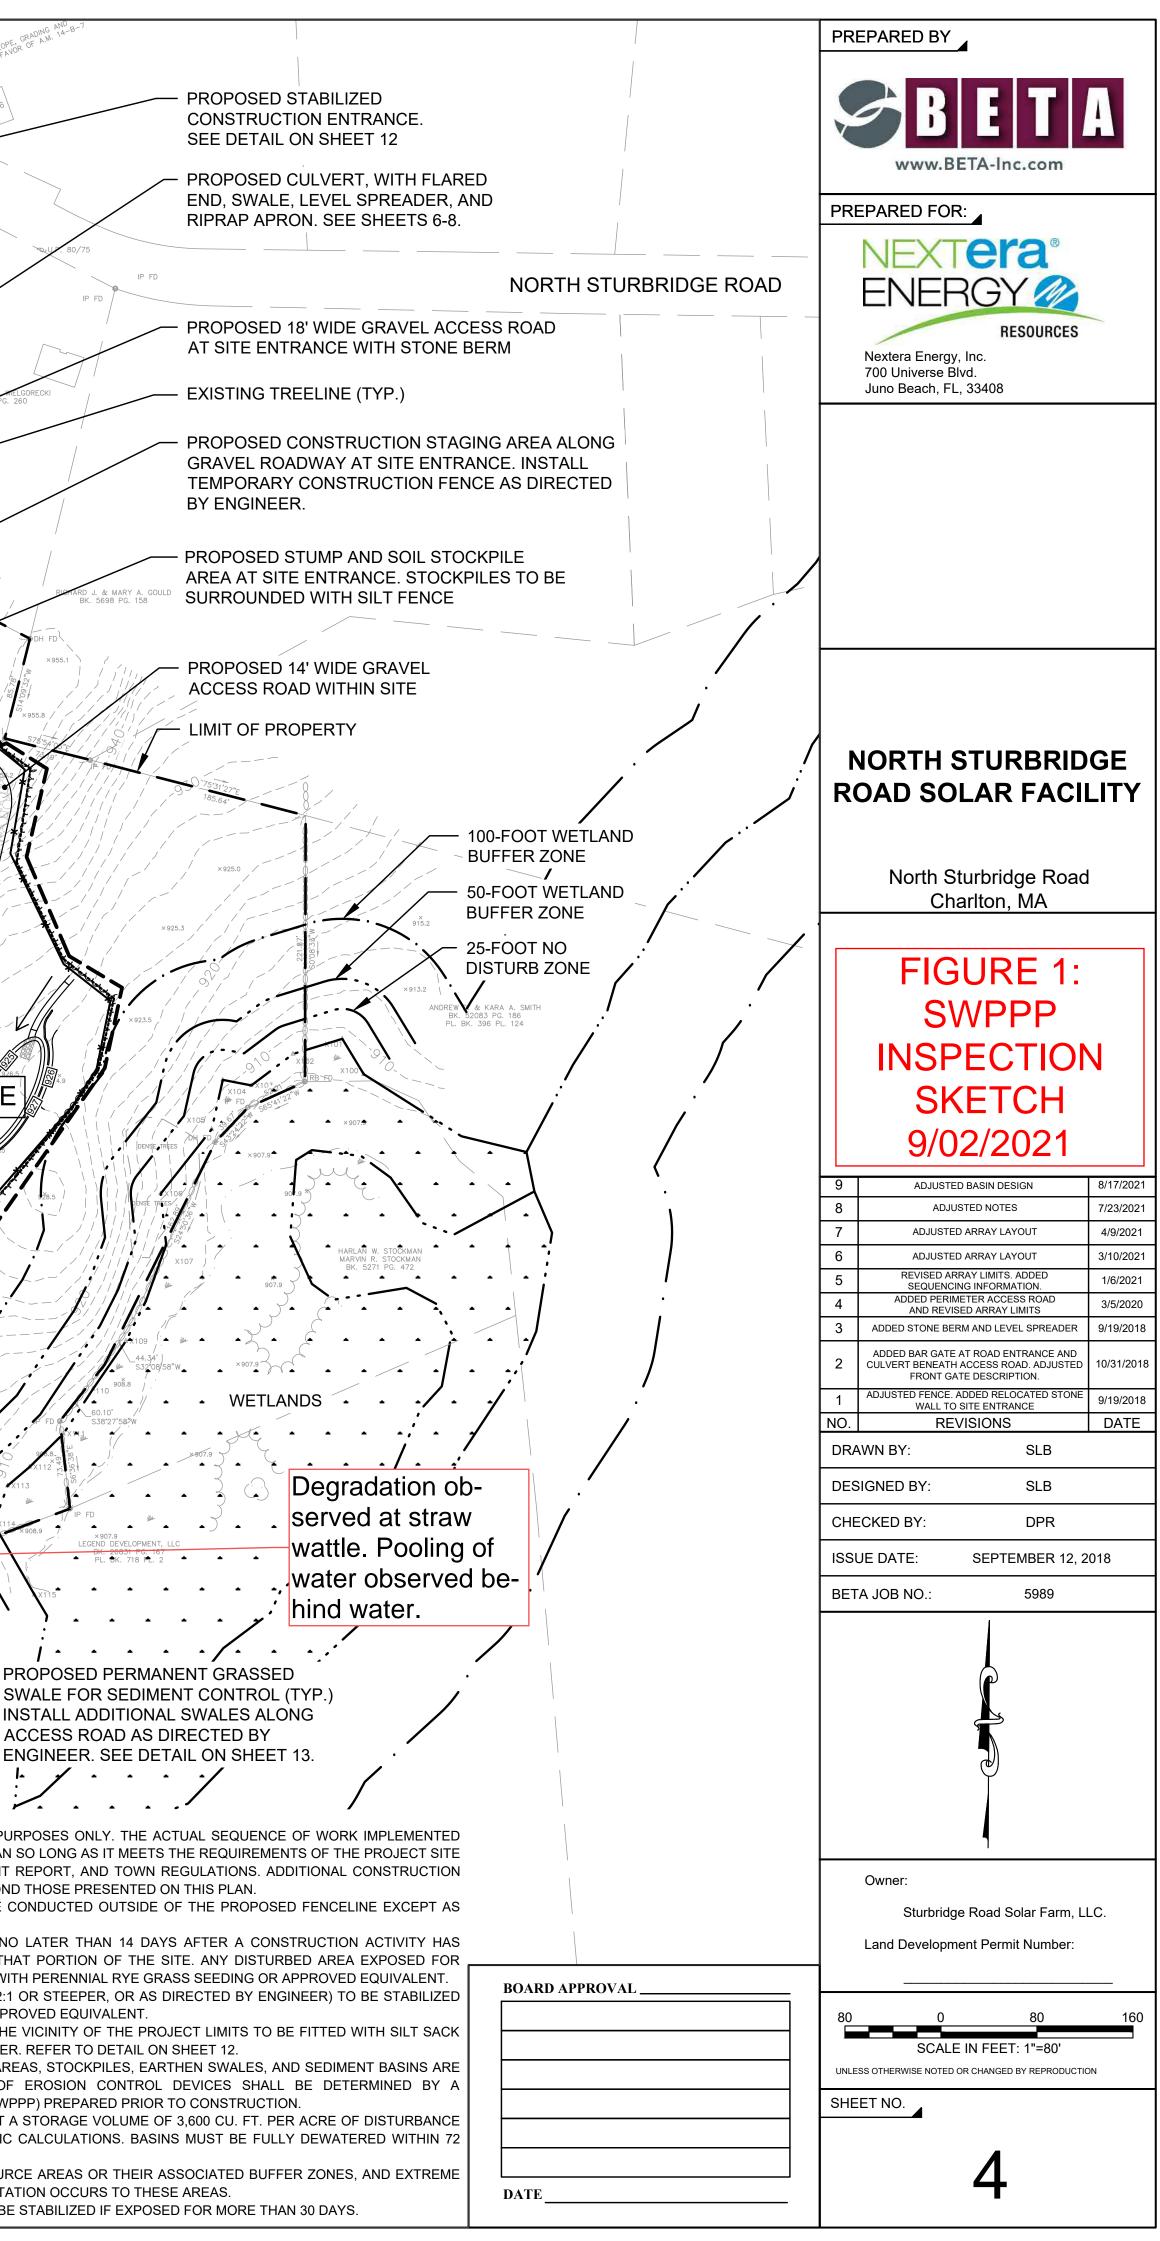
### Photo 1

1. Silt Fence and Straw Wattles	Yes (As of 9/2/2021)	No	9/2/2021	A breach was observed at Discharge 2. Although the double row of straw bales is intact, silt fence was observed to be knocked over and signs of stormwater flow were detected in the area beyond the fence. A minor tear was identified in a section of silt fence on the southern side of the Site with no erosion observed. Minor degradation of a straw wattle was observed on the southeastern side of the Site; no erosion was observed but pools of water were found to be forming behind the straw wattle

View of the damage erosion control measures associated with Discharge 2—facing north.
