Inspection Report for North Sturbridge Road Solar Facility NPDES ID No.: MAR10031G Inspection Date: 09/17/2021

PHOTOGRAPHIC DOCUMENTATION North Sturbridge Road Solar Facility Charlton, Massachusetts Photographs Documented 09.17.2021

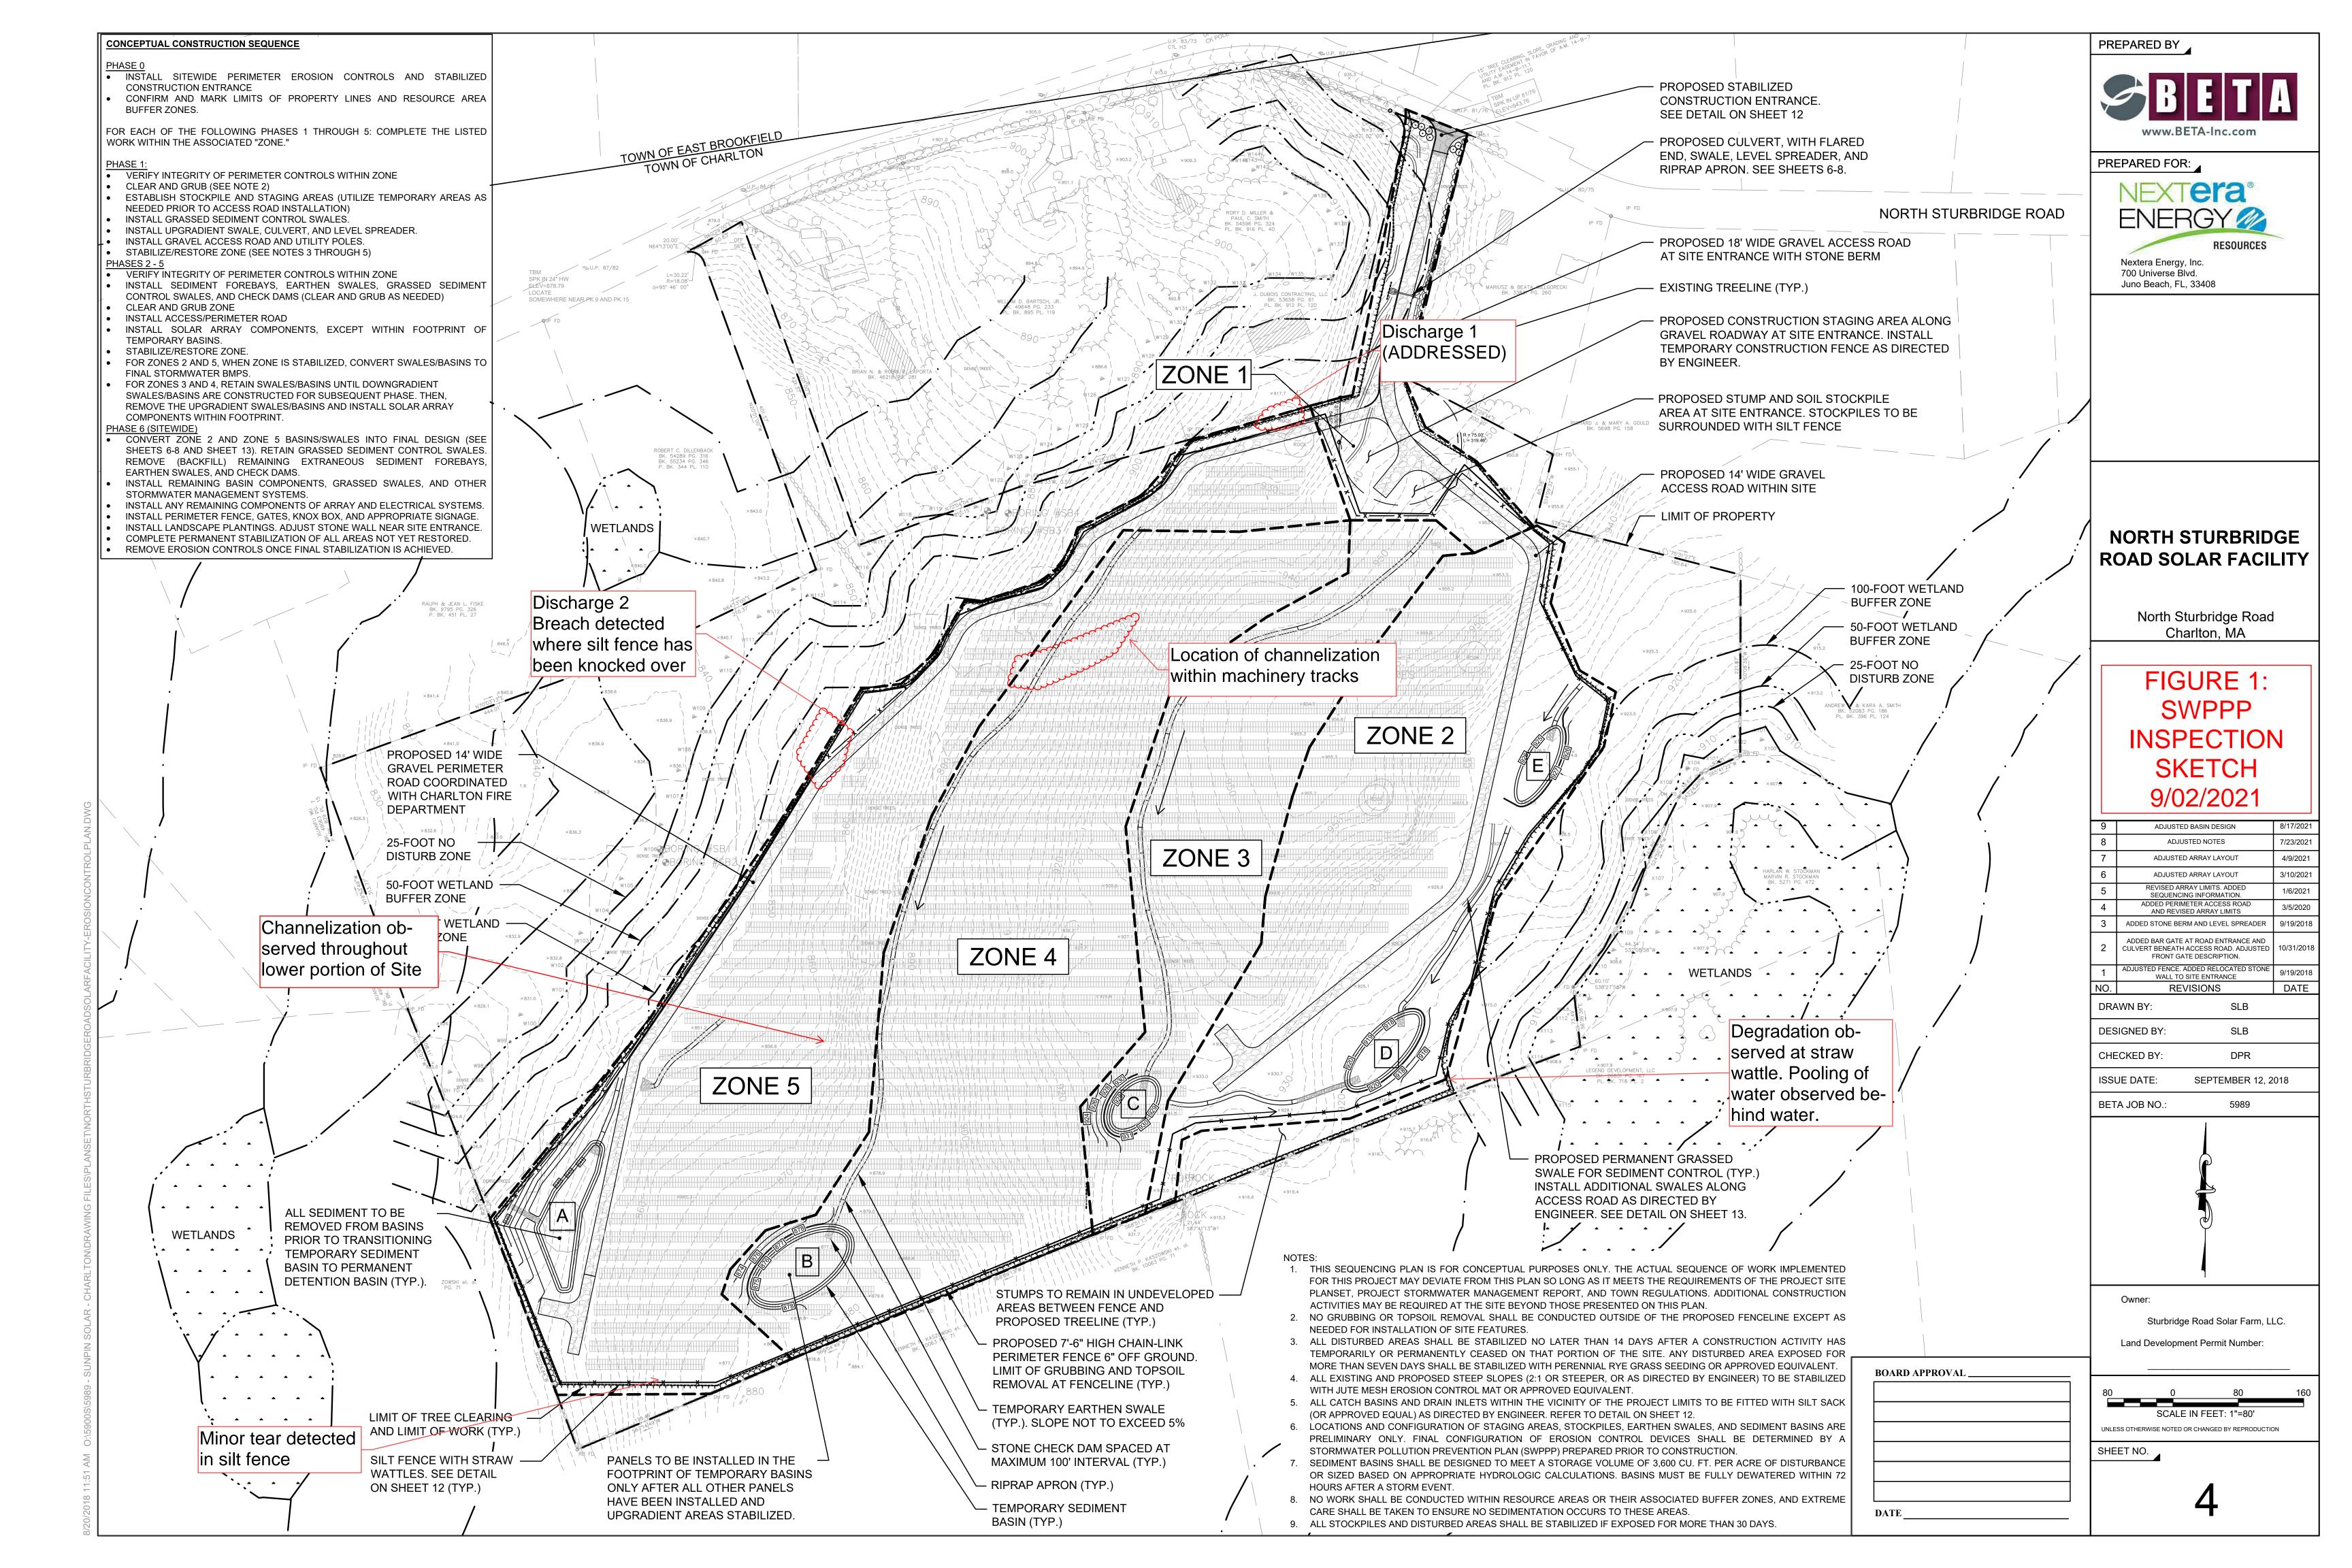
Photo 1

1. Silt Fence and Straw Wattles	Yes (As of 9/2/2021)	No	9/2/ 2021	A breach was observed at Discharge 2. Although the double row of straw bales is intact, silt fence was observed to be knocked over and signs of stormwater flow were detected in the area beyond the fence. A minor tear was identified in a section of silt fence on the southern side of the Site with no erosion observed. Minor degradation of a straw wattle was observed on the southeastern side of the Site; no erosion was observed but pools of water were found to be forming behind the straw wattle.
Stabilized Construction Entrance (Site Entrance – Access Road)	No (As of 9/2/2021)	No		A tree was knocked over and laying on the silt fence on the on the northwestern portion of the site in Zone 5. Hydroseed was applied to exposed soil in this area and continues to
