Inspection Report for North Sturbridge Road Solar Facility NPDES ID No.: MAR10031G Inspection Date: 7/5/2022

PHOTOGRAPHIC DOCUMENTATION North Sturbridge Road Solar Facility Charlton, Massachusetts Photographs Documented 7.5.2022

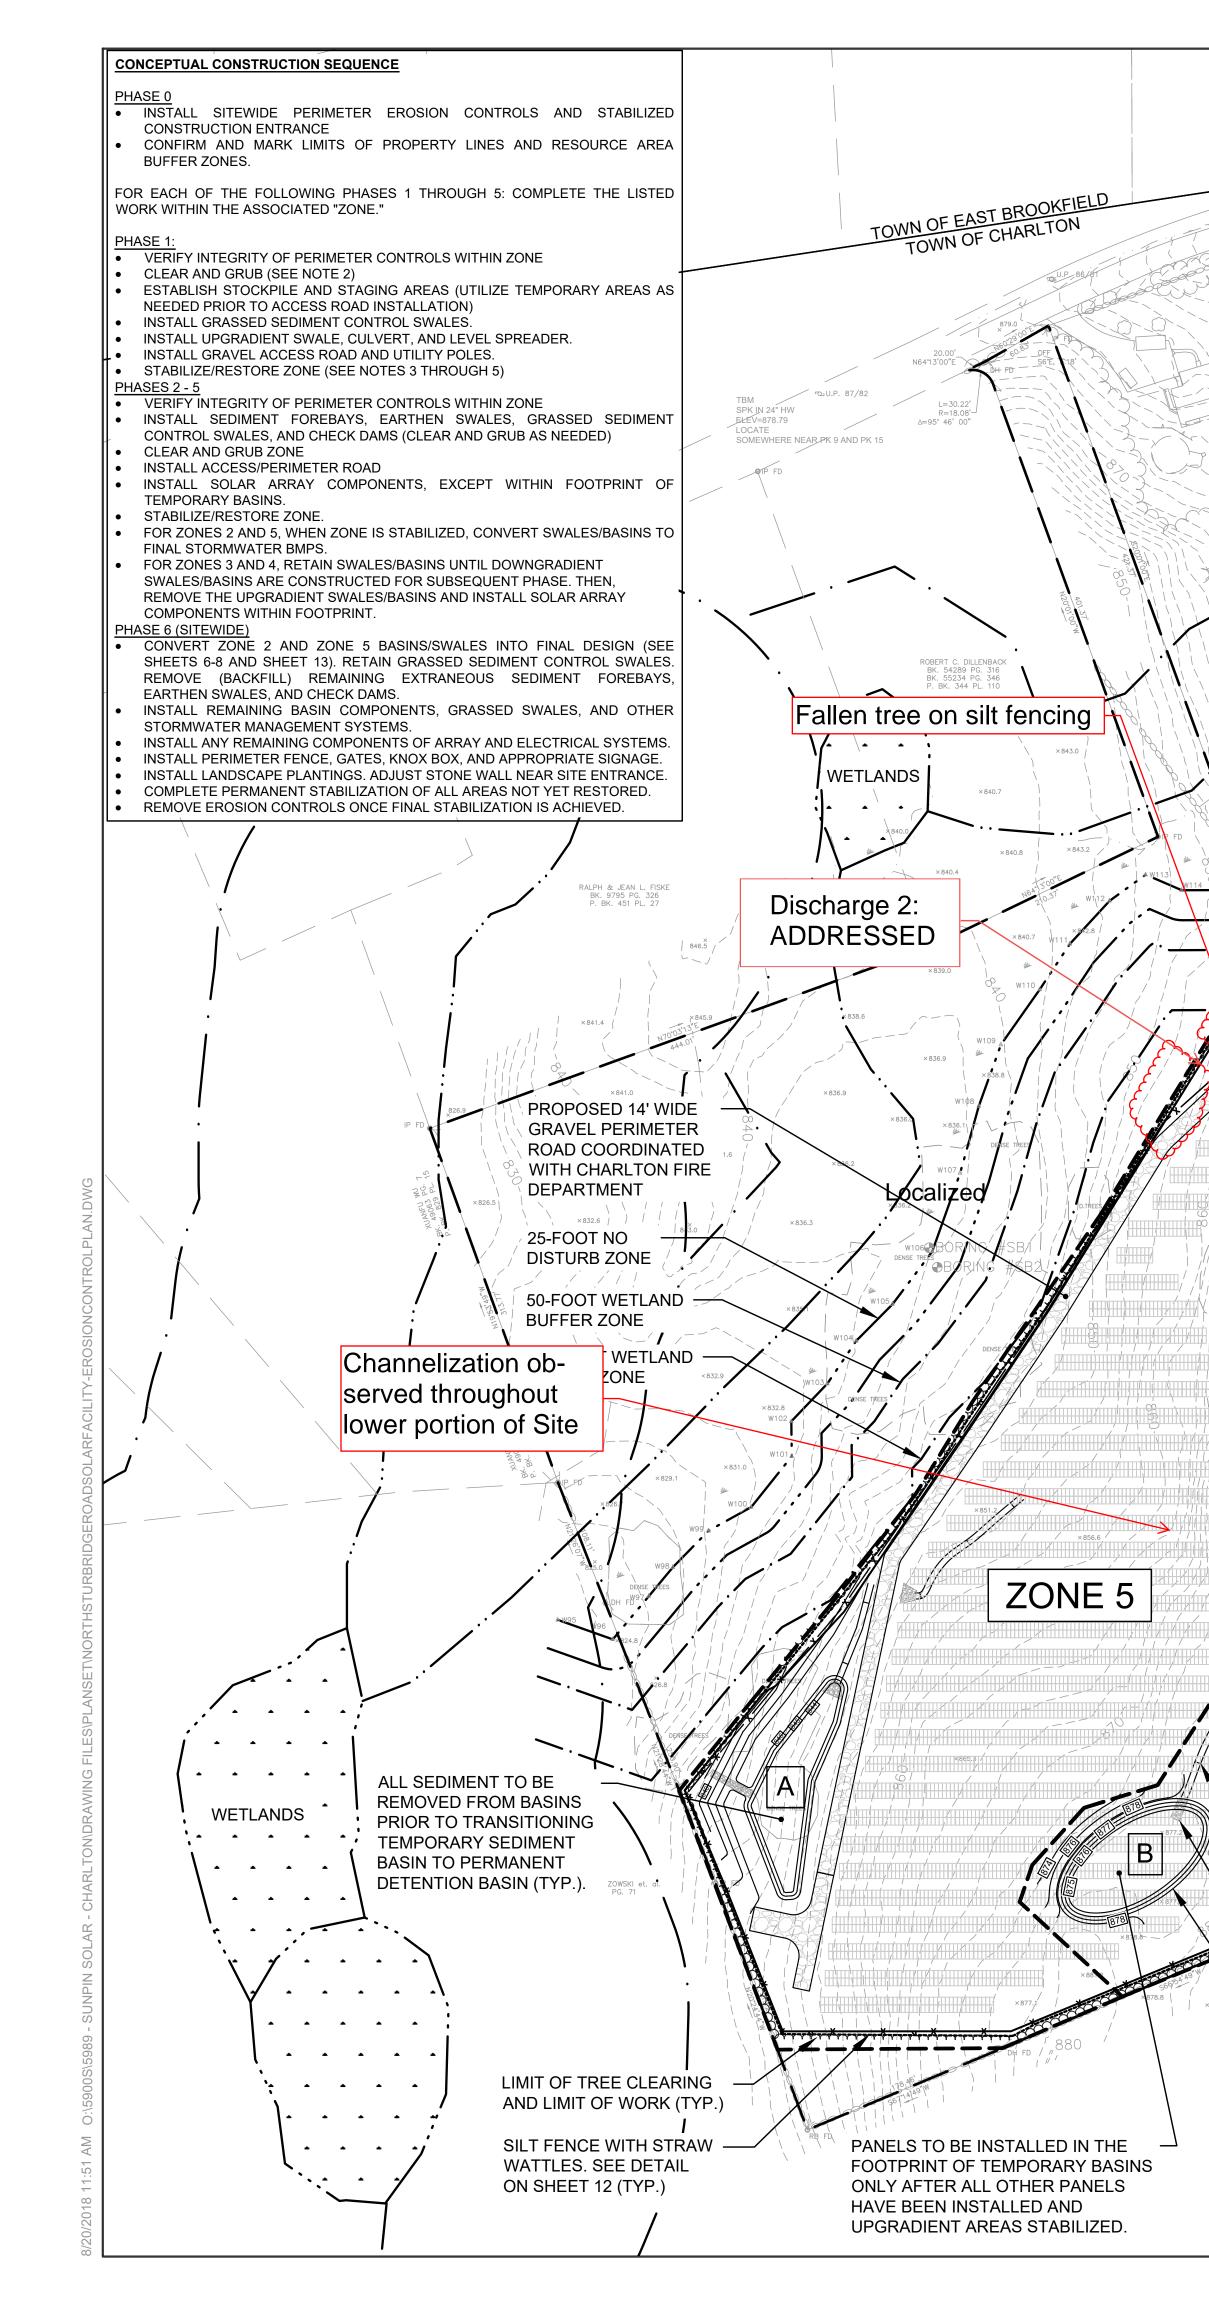
Discharge 1: ADDRESSED

Location of channelization within machinery tracks

temporary swales would likely alleviate the issue of channelization in this area; however, these swales will not be constructed until work resumes at the Site in the spring (pending local approval). This area will continue to be monitored; however, stabilization is not required since the area is not discharging sediment beyond the limits of work.
 Area beyond the limits of work at Discharge 1 	Hand application of seed	Yes 8/24/2021	□No	The sediment deposit previously observed has been removed from beyond the limits of work and the area has been seeded. No sediment migrated within 50 feet of a "water of the US". Straw and additional seed was applied on 8/24/2021.
				On 10/2/2021 BETA verified that grass seed had been successful established at Discharge 1 and 2. BETA will continue to monitor grass growth.
 Area beyond limits of work at Discharge 2 	Hand application of seed	Yes 8/24/2021	□No	On 4/8/2022 BETA observed the recently seeded grass to be thriving.
