# Flow Assessment Services, LLC. Structure Inspection Log

Municipality:	Hull, MA	Manhole No.:	20696
Street:	40 Whitehead Avenue	Sub-System:	4
Inspection Date:	4/29/2020	Inspector:	MA
		Map #:

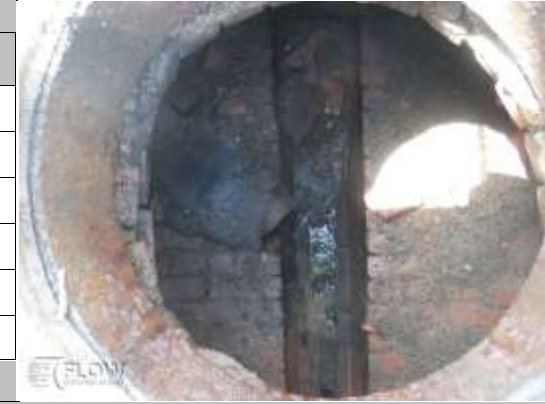
Cracked pavement surrounding frame

ITEM	MATERIAL	CONDITION	Leaks (gpm)	DEFECTS
FRAME	CAST	1		
CORBEL	BRICK	2		Missing mortar
STEPS	NONE	0		
WALLS	BRICK	1		
FLOOR	BRICK	2		Missing mortar
INVERT	BRICK	2		Missing mortar

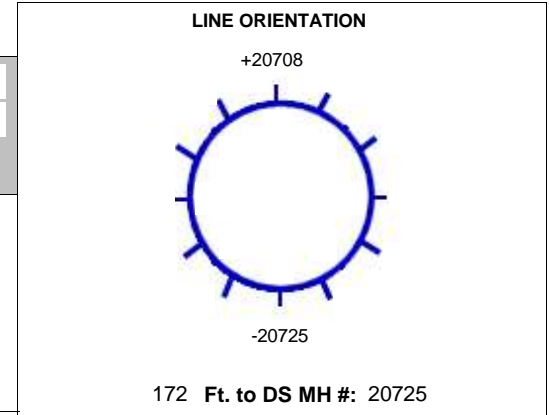
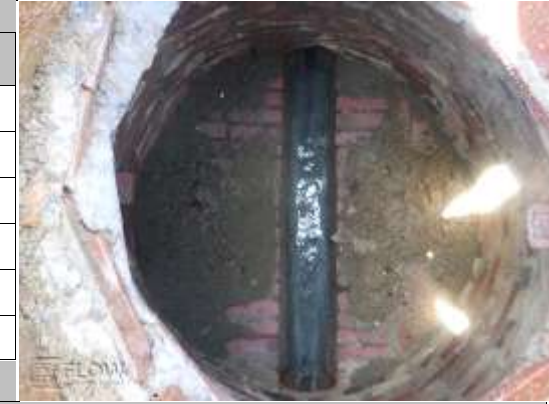
Municipality:	Hull, MA	Manhole No.:	20718
Street:	27 Whitehead Avenue	Sub-System:	4
Inspection Date:	4/29/2020	Inspector:	MA
		Map #:

Cracked pavement surrounding frame

ITEM	MATERIAL	CONDITION	Leaks (gpm)	DEFECTS
FRAME	CAST	1		
CORBEL	BRICK	1		
STEPS	BRICK	1		
WALLS	BRICK	1		
FLOOR	BRICK	1		
INVERT	PARGED	1

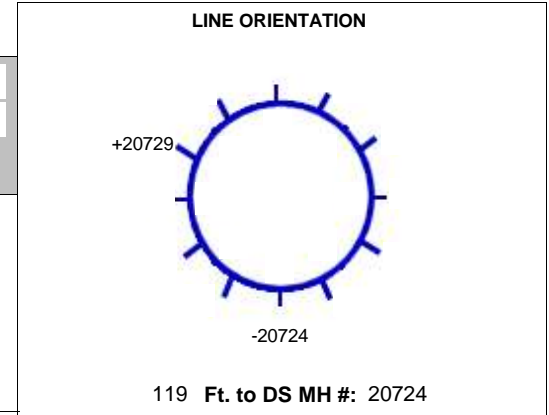
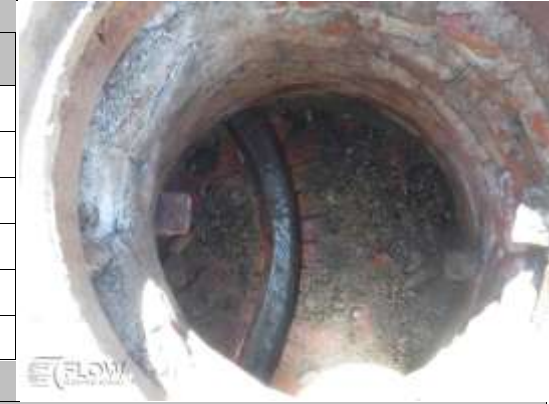
Municipality:	Hull, MA	Manhole No.:	20723
Street:	93 Hampton Circle	Sub-System:	4
Inspection Date:	5/4/2020	Inspector:	MA
		Map #:

ITEM	MATERIAL	CONDITION	Leaks (gpm)	DEFECTS
FRAME	CAST	1		
CORBEL	BRICK	1		
STEPS	BRICK	1		
WALLS	BRICK	1		
FLOOR	BRICK	1		
INVERT	BRICK	1

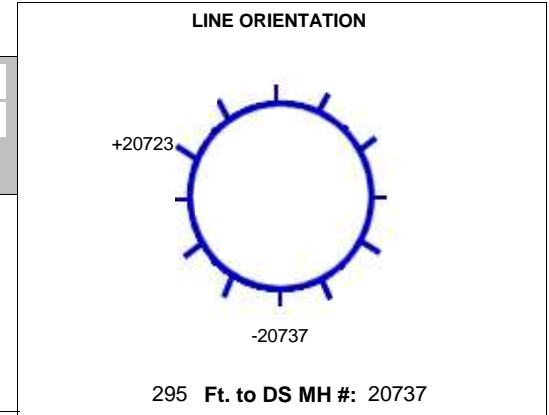
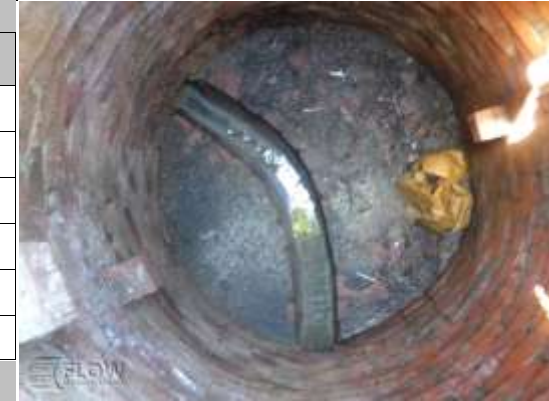
Municipality:	Hull, MA	Manhole No.:	20724
Street:	99 Hampton Circle	Sub-System:	4
Inspection Date:	5/4/2020	Inspector:	MA
		Map #:

ITEM	MATERIAL	CONDITION	Leaks (gpm)	DEFECTS
FRAME	CAST	1		
CORBEL	BRICK	2		Roots
STEPS	BRICK	1		
WALLS	BRICK	2		Roots
FLOOR	BRICK	1		
INVERT	BRICK	1

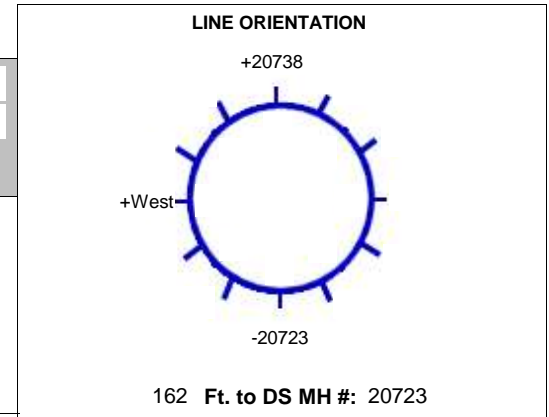
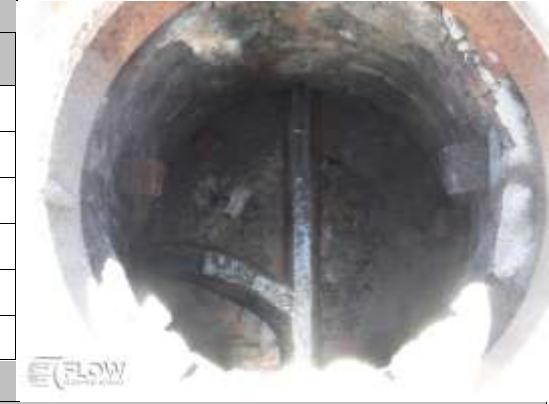
Municipality:	Hull, MA	Manhole No.:	20729
Street:	89 Hampton Circle	Sub-System:	4
Inspection Date:	5/4/2020	Inspector:	MA
		Map #:

ITEM	MATERIAL	CONDITION	Leaks (gpm)	DEFECTS
FRAME	CAST	1		
CORBEL	BRICK	2		Missing mortar
STEPS	BRICK	1		
WALLS	BRICK	1		
FLOOR	BRICK	1		
INVERT	BRICK	1

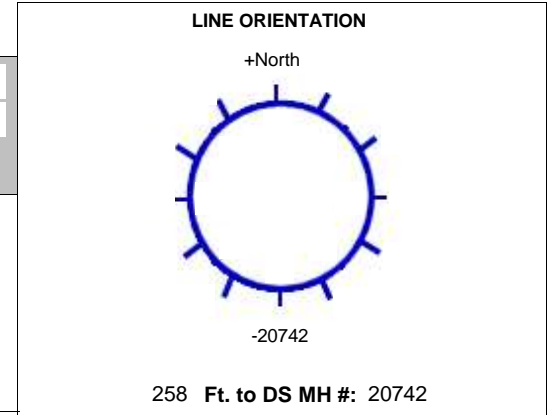
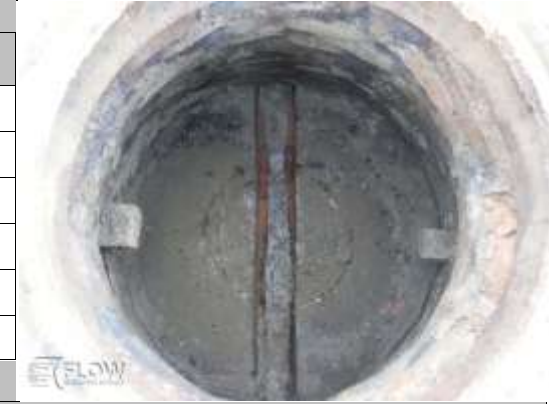
Municipality:	Hull, MA	Manhole No.:	20735
Street:	6 Old Colony Road	Sub-System:	4
Inspection Date:	4/30/2020	Inspector:	MA
		Map #:

ITEM	MATERIAL	CONDITION	Leaks (gpm)	DEFECTS
FRAME	CAST	1		
CORBEL	BRICK	1		
STEPS	BRICK	1		
WALLS	BRICK	1		
FLOOR	BRICK	1		
INVERT	BRICK	1

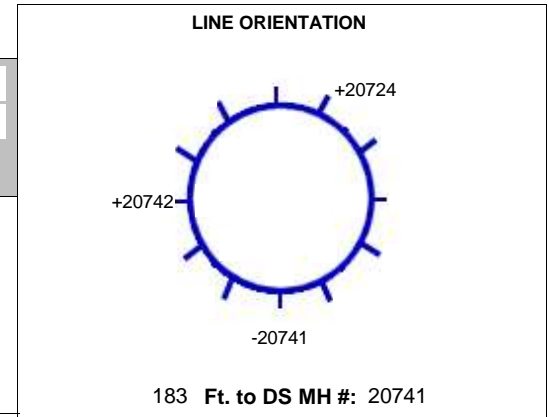
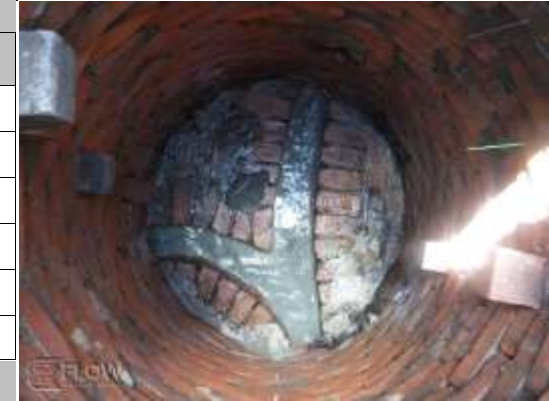
Municipality:	Hull, MA	Manhole No.:	20737
Street:	17 Hampton Circle	Sub-System:	4
Inspection Date:	5/4/2020	Inspector:	MA
		Map #:

ITEM	MATERIAL	CONDITION	Leaks (gpm)	DEFECTS
FRAME	CAST	1		
CORBEL	BRICK	3		Missing brick, Missing mortar
STEPS	BRICK	1		
WALLS	BRICK	3	0.1	Weeping infiltration
FLOOR	BRICK	1		
INVERT	BRICK	1

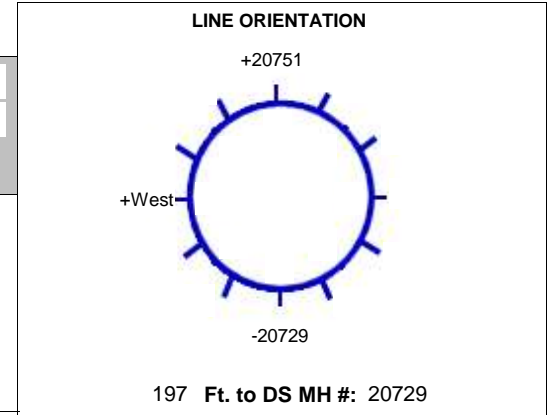
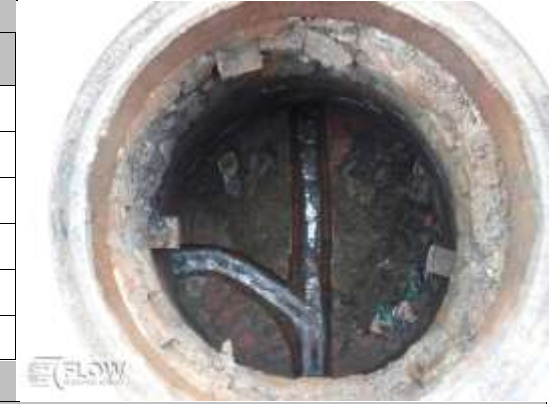
Municipality:	Hull, MA	Manhole No.:	20738
Street:	77 Hampton Circle	Sub-System:	4
Inspection Date:	4/30/2020	Inspector:	MA
		Map #:

ITEM	MATERIAL	CONDITION	Leaks (gpm)	DEFECTS
FRAME	CAST	1		
CORBEL	BRICK	2		Missing mortar
STEPS	BRICK	1		
WALLS	BRICK	1		
FLOOR	BRICK	1		
INVERT	BRICK	1

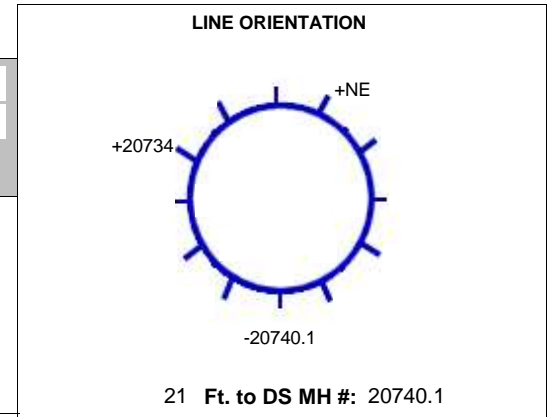
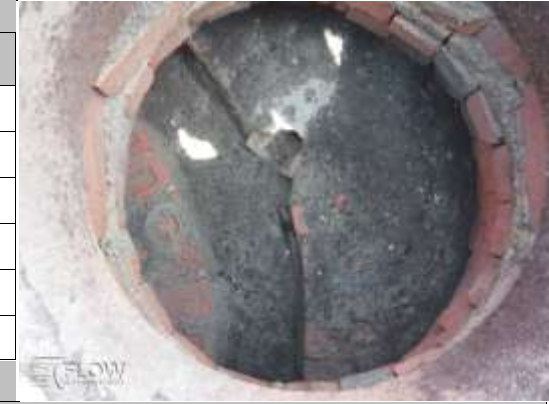
Municipality:	Hull, MA	Manhole No.:	20740
Street:	Nantasket Avenue	Sub-System:	4
Inspection Date:	4/29/2020	Inspector:	MA
		Map #:

Cracked pavement surrounding frame

ITEM	MATERIAL	CONDITION	Leaks (gpm)	DEFECTS
FRAME	CAST	1		
CORBEL	BRICK	1		
STEPS	NONE	0		
WALLS	BRICK	1		
FLOOR	BRICK	1		
INVERT	BRICK	1

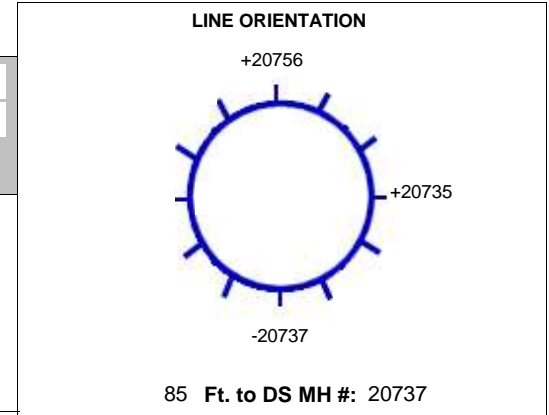
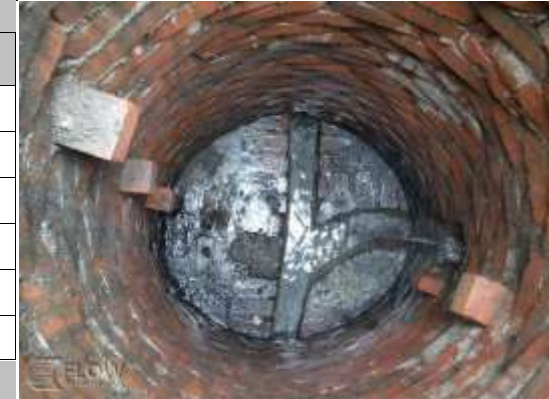
Municipality:	Hull, MA	Manhole No.:	20742
Street:	117 Hampton Circle	Sub-System:	4
Inspection Date:	4/30/2020	Inspector:	MA
		Map #:

Cracked pavement surrounding frame

ITEM	MATERIAL	CONDITION	Leaks (gpm)	DEFECTS
FRAME	CAST	1		
CORBEL	BRICK	2		Missing mortar
STEPS	BRICK	1		
WALLS	BRICK	4	0.1	Dripping infiltration
FLOOR	BRICK	1		
INVERT	BRICK	1

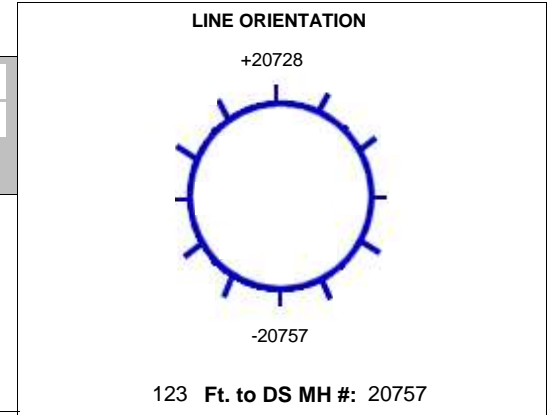
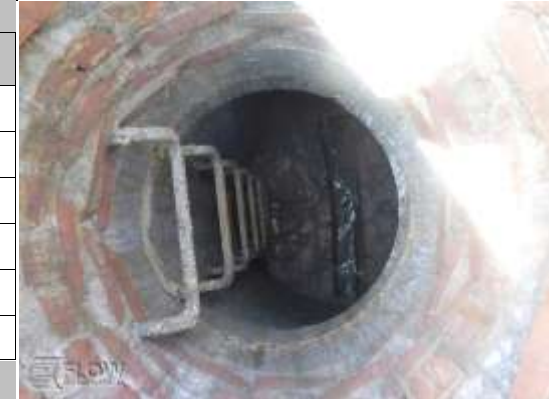
Municipality:	Hull, MA	Manhole No.:	20746
Street:	8 Edgewater Road	Sub-System:	4
Inspection Date:	4/29/2020	Inspector:	MA
		Map #:

ITEM	MATERIAL	CONDITION	Leaks (gpm)	DEFECTS
FRAME	CAST	1		
CORBEL	BRICK	1		
STEPS	ALUM	1		
WALLS	PRECAST	1		
FLOOR	BRICK	1		
INVERT	BRICK	1

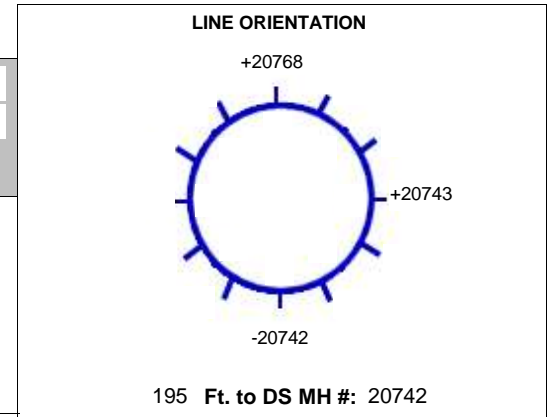
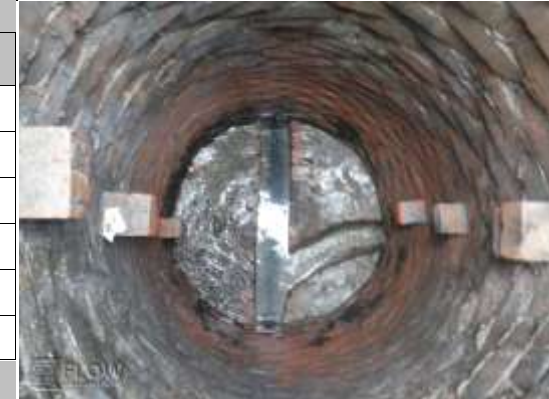
Municipality:	Hull, MA	Manhole No.:	20756
Street:	125 Hampton Circle	Sub-System:	4
Inspection Date:	4/30/2020	Inspector:	MA
		Map #:

Cracked and missing pavement surrounding frame

ITEM	MATERIAL	CONDITION	Leaks (gpm)	DEFECTS
FRAME	CAST	1		
CORBEL	BRICK	2		Missing mortar
STEPS	BRICK	1		
WALLS	BRICK	3		Weeping infiltration
FLOOR	BRICK	1		
INVERT	BRICK	1

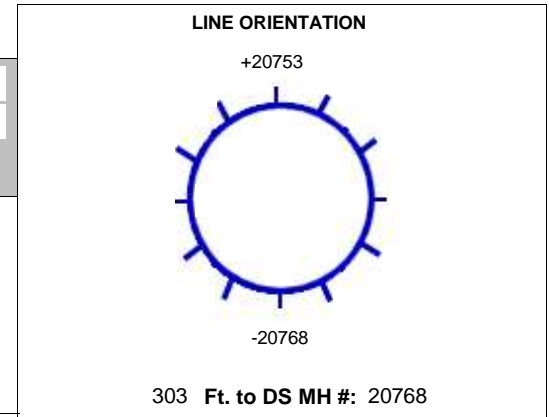
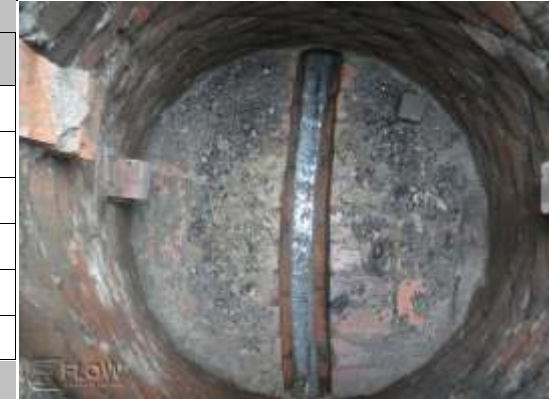
Municipality:	Hull, MA	Manhole No.:	20758
Street:	7 Standish Road	Sub-System:	4
Inspection Date:	4/30/2020	Inspector:	MA
		Map #:

Cracked pavement surrounding frame

ITEM	MATERIAL	CONDITION	Leaks (gpm)	DEFECTS
FRAME	CAST	1		
CORBEL	BRICK	1		
STEPS	BRICK	3		Broken
WALLS	BRICK	1		
FLOOR	BRICK	1		
INVERT	BRICK	1

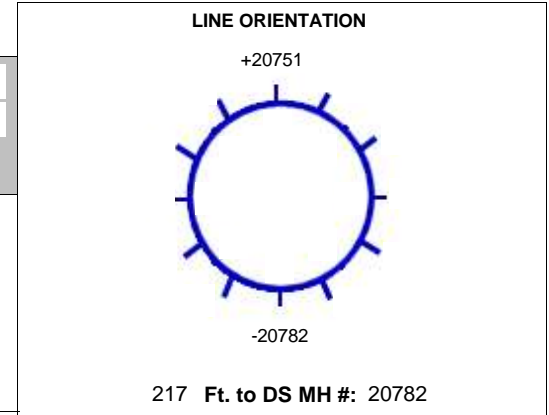
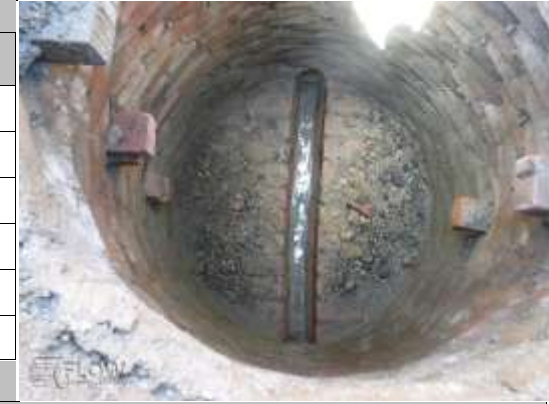
Municipality:	Hull, MA	Manhole No.:	20763
Street:	61 Hampton Circle	Sub-System:	4
Inspection Date:	5/4/2020	Inspector:	MA
		Map #:

Cracked pavement surrounding frame

ITEM	MATERIAL	CONDITION	Leaks (gpm)	DEFECTS
FRAME	CAST	1		
CORBEL	BRICK	1		
STEPS	BRICK	1		
WALLS	BRICK	1		
FLOOR	BRICK	1		
INVERT	BRICK	1

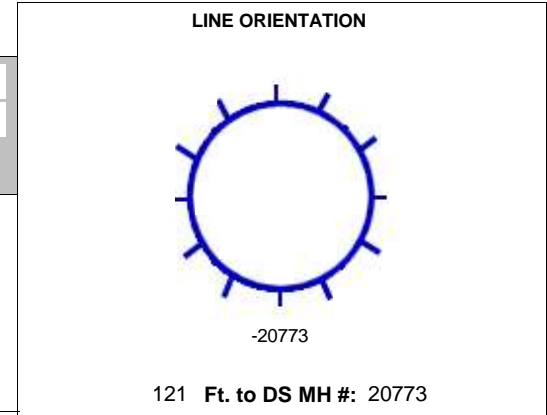
Municipality:	Hull, MA	Manhole No.:	20767
Street:	2 Mayflower Avenue	Sub-System:	4
Inspection Date:	5/4/2020	Inspector:	MA
		Map #:

Starter Manhole, Cracked pavement surrounding frame

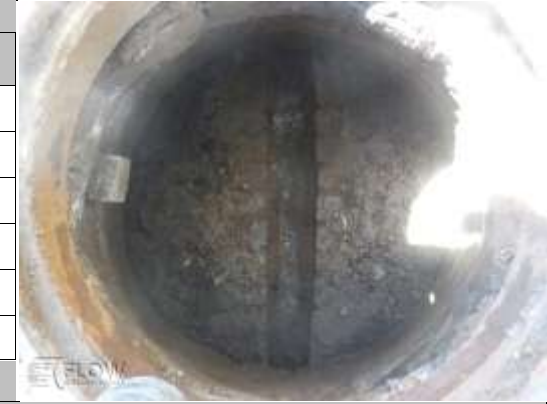
ITEM	MATERIAL	CONDITION	Leaks (gpm)	DEFECTS
FRAME	CAST	1		
CORBEL	BRICK	2		Missing mortar
STEPS	BRICK	1		
WALLS	BRICK	1		
FLOOR	BRICK	1		
INVERT	BRICK	1

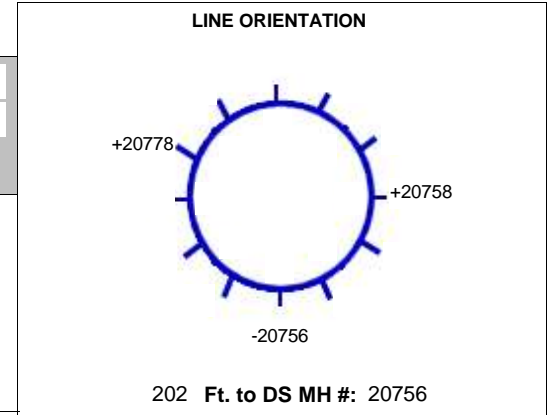
Municipality:	Hull, MA	Manhole No.:	20768
Street:	20 Standish Road	Sub-System:	4
Inspection Date:	4/30/2020	Inspector:	MA
		Map #:

Cracked pavement surrounding frame

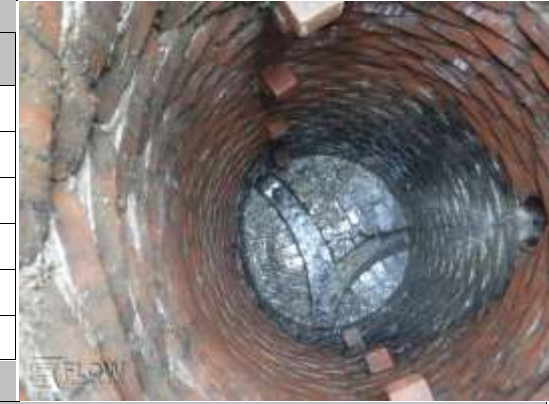
ITEM	MATERIAL	CONDITION	Leaks (gpm)	DEFECTS
FRAME	CAST	1		
CORBEL	BRICK	1		
STEPS	BRICK	1		
WALLS	BRICK	3	0.1	Weeping infiltration
FLOOR	BRICK	1		
INVERT	BRICK	1

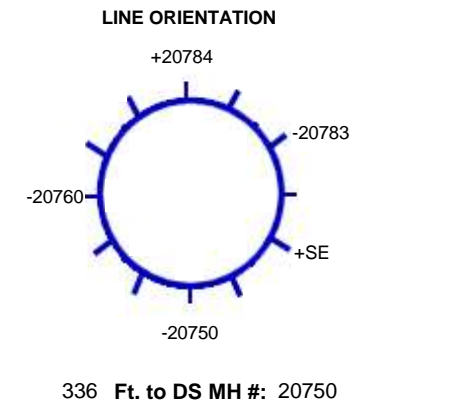
Cracked pavement surrounding frame

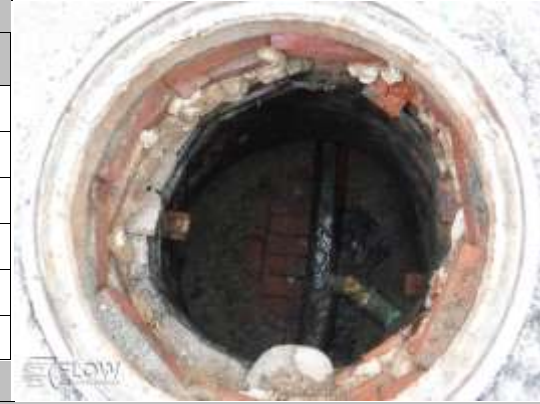
ITEM	MATERIAL	CONDITION	Leaks (gpm)	DEFECTS
FRAME	CAST	1		
CORBEL	BRICK	3		Loose brick
STEPS	BRICK	1		
WALLS	BRICK	2		Staining
FLOOR	BRICK	1		
INVERT	BRICK	1

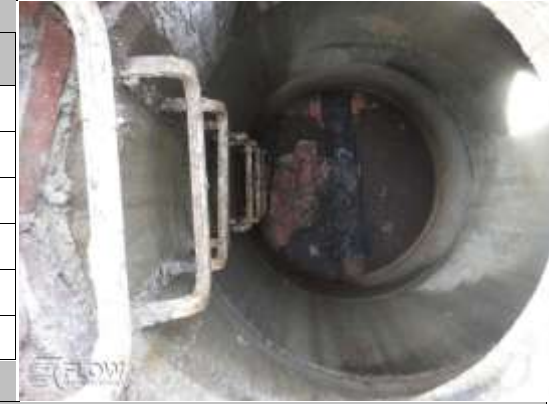
ITEM	MATERIAL	CONDITION	Leaks (gpm)	DEFECTS
FRAME	CAST	1		
CORBEL	BRICK	1		
STEPS	ALUM	1		
WALLS	PRECAST	1		
FLOOR	BRICK	1		
INVERT	CNI	0		Sediment

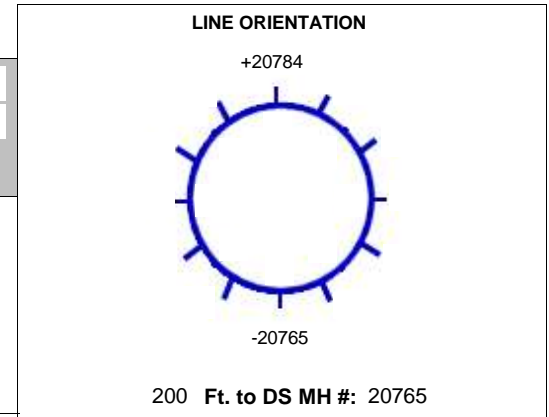
Municipality:	Hull, MA	Manhole No.:	20775
Street:	7 Islandview Road	Sub-System:	4
Inspection Date:	4/30/2020	Inspector:	MA
		Map #:

Cracked pavement surrounding frame

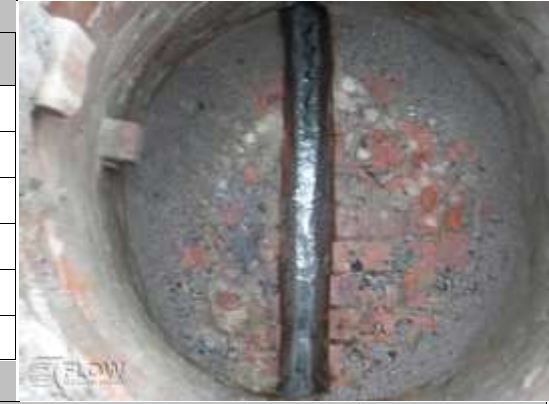
ITEM	MATERIAL	CONDITION	Leaks (gpm)	DEFECTS
FRAME	CAST	1		
CORBEL	BRICK	2		Missing mortar
STEPS	BRICK	1		
WALLS	BRICK	1		
FLOOR	BRICK	1		
INVERT	BRICK	1

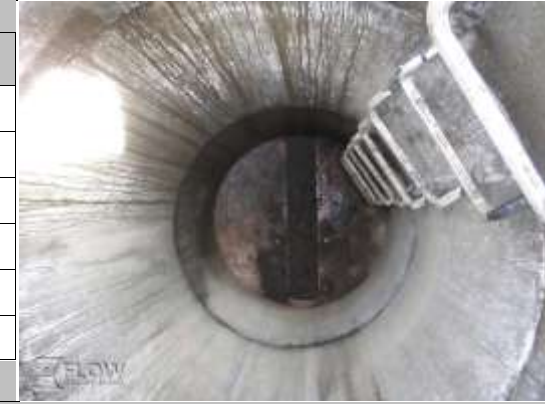
Starter Manhole, Outside collar cracked and broken from frame

ITEM	MATERIAL	CONDITION	Leaks (gpm)	DEFECTS
FRAME	CAST	2		Offset 2", Loose
CORBEL	PARGED	2		Missing mortar
STEPS	ALUM	1		
WALLS	PRECAST	1		
FLOOR	BRICK	1		
INVERT	CNI	0		Sediment

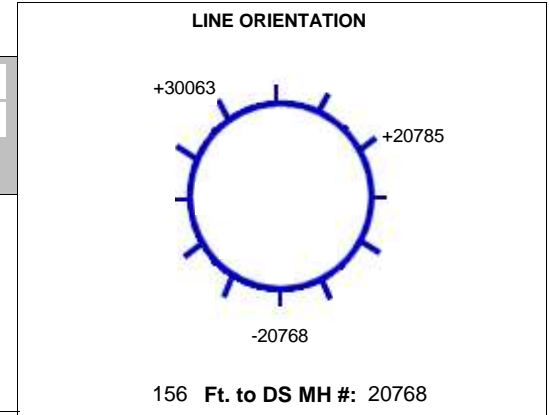
Municipality:	Hull, MA	Manhole No.:	20778
Street:	Morland Avenue and Hampton Circle	Sub-System:	4
Inspection Date:	4/30/2020	Inspector:	MA
		Map #:

Cracked pavement surrounding frame

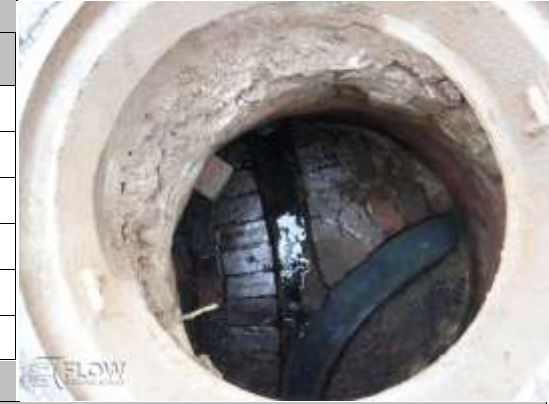
ITEM	MATERIAL	CONDITION	Leaks (gpm)	DEFECTS
FRAME	CAST	2		Offset 5"
CORBEL	BRICK	1		
STEPS	BRICK	1		
WALLS	BRICK	4		Running infiltration
FLOOR	BRICK	1		
INVERT	BRICK	1

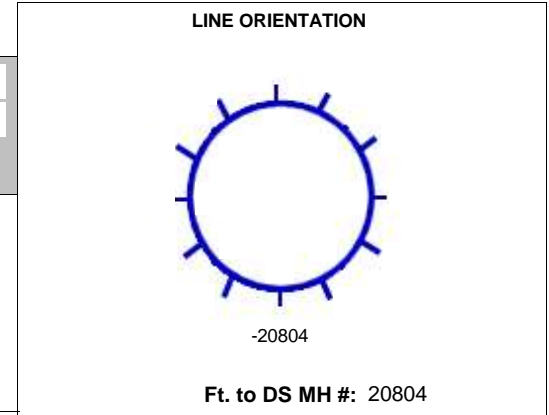
Municipality:	Hull, MA	Manhole No.:	20780
Street:	Sagamore Terrace	Sub-System:	4
Inspection Date:	4/30/2020	Inspector:	MA
		Map #:

Starter Manhole, Cracked and missing pavement surrounding frame

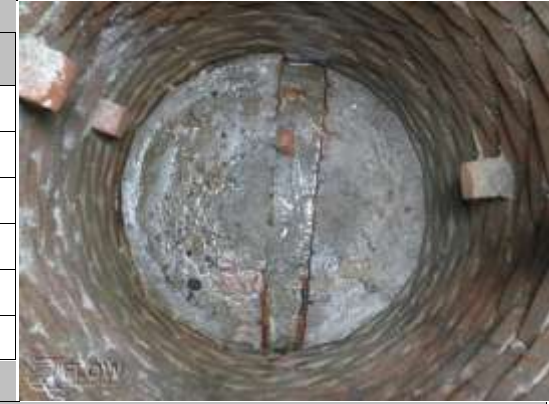
ITEM	MATERIAL	CONDITION	Leaks (gpm)	DEFECTS
FRAME	CAST	1		
CORBEL	BRICK	1		
STEPS	BRICK	1		
WALLS	BRICK	3	0.1	Dripping infiltration
FLOOR	BRICK	1		
INVERT	BRICK	4	0.1	Running infiltration

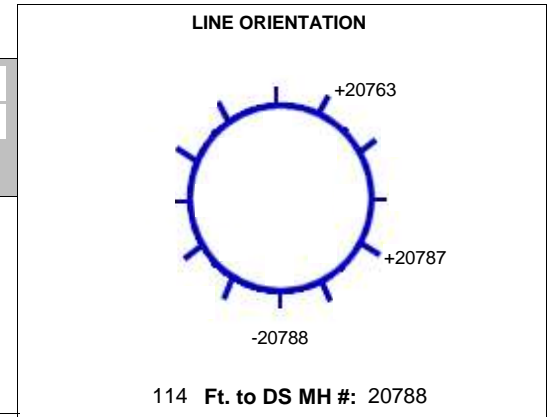
Municipality:	Hull, MA	Manhole No.:	20782
Street:	55 Hampton Circle	Sub-System:	4
Inspection Date:	5/4/2020	Inspector:	MA
		Map #:

Cracked pavement surrounding frame

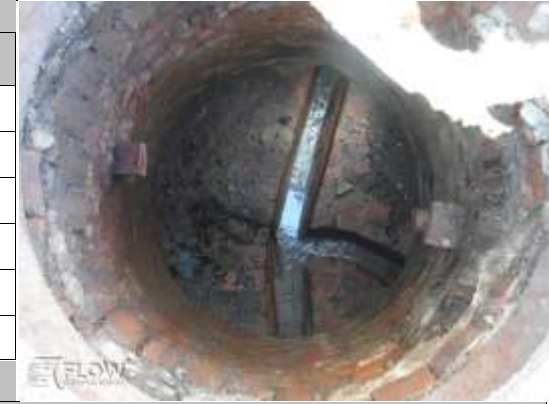
ITEM	MATERIAL	CONDITION	Leaks (gpm)	DEFECTS
FRAME	CAST	1		
CORBEL	BRICK	2		Deteriorating brick, Missing mortar
STEPS	BRICK	1		
WALLS	BRICK	1		
FLOOR	BRICK	1		
INVERT	BRICK	1

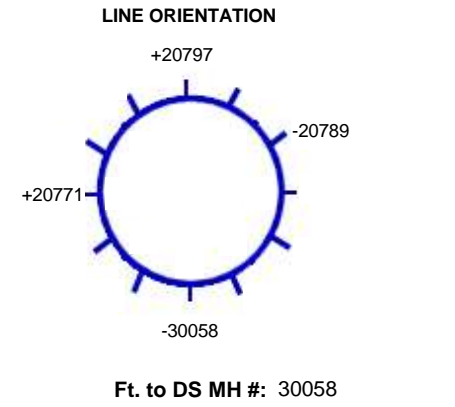
<b>Municipality:</b>	Hull, MA	<b>Manhole No.:</b>	20783
<b>Street:</b>	Rosevelt Avenue and Fairmont Way	<b>Sub-System:</b>	4
<b>Inspection Date:</b>	4/30/2020	<b>Inspector:</b>	MA
		<b>Map #:</b>

Cracked pavement surrounding frame

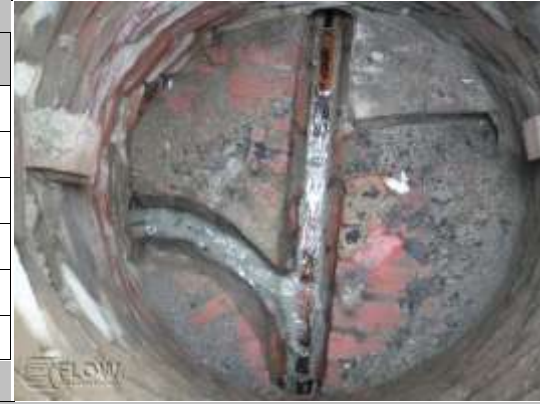
ITEM	MATERIAL	CONDITION	Leaks (gpm)	DEFECTS
FRAME	CAST	3		Cracked
CORBEL	BRICK	2		Missing mortar
STEPS	BRICK	1		
WALLS	BRICK	2		Staining
FLOOR	BRICK	1		
INVERT	BRICK	1

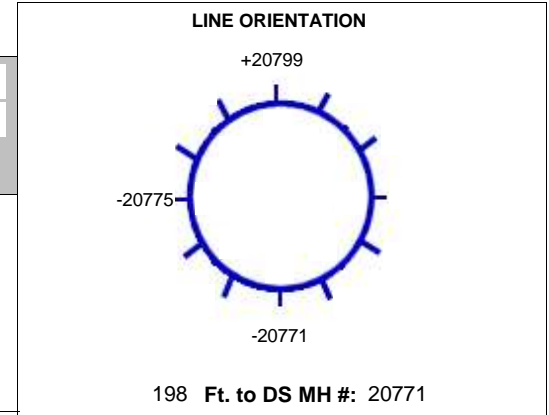
Municipality:	Hull, MA	Manhole No.:	20784
Street:	Merrill Road and Islandview Road	Sub-System:	4
Inspection Date:	4/30/2020	Inspector:	MA
		Map #:

Cracked pavement surrounding frame

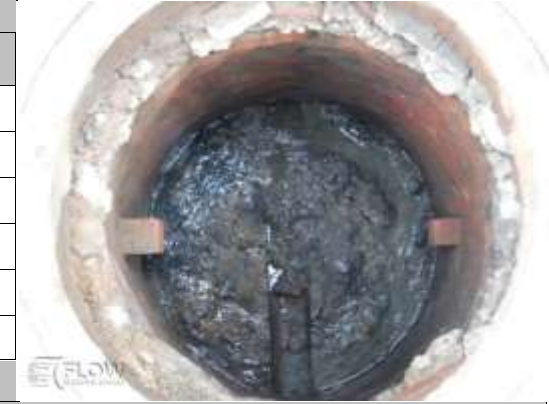
ITEM	MATERIAL	CONDITION	Leaks (gpm)	DEFECTS
FRAME	CAST	1		
CORBEL	BRICK	2		Missing mortar
STEPS	BRICK	1		
WALLS	BRICK	1		
FLOOR	CNI	0		Blockage
INVERT	CNI	0		Blockage

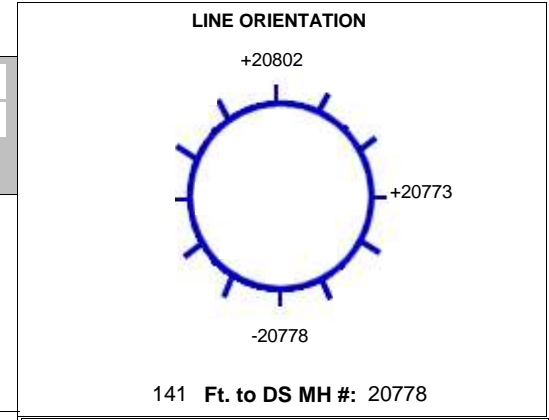
Municipality:	Hull, MA	Manhole No.:	20785
Street:	3 Hampton Circle	Sub-System:	4
Inspection Date:	5/4/2020	Inspector:	MA
		Map #:

Cracked and missing pavement surrounding frame

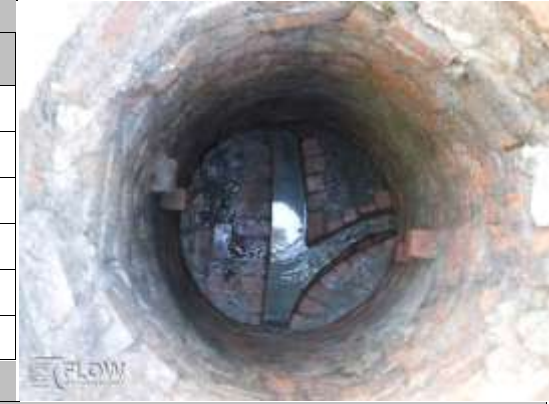
ITEM	MATERIAL	CONDITION	Leaks (gpm)	DEFECTS
FRAME	CAST	1		
CORBEL	BRICK	2		Deteriorating brick
STEPS	BRICK	1		
WALLS	BRICK	2		Staining
FLOOR	BRICK	1		
INVERT	BRICK	1

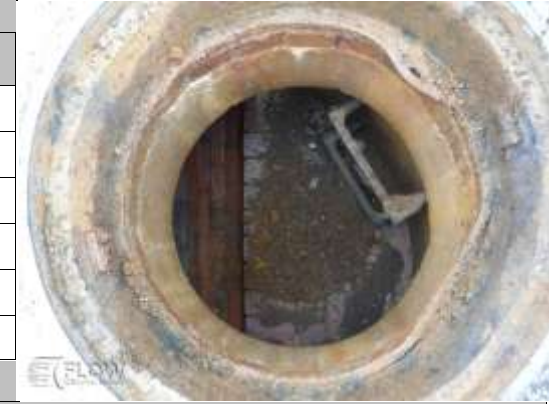
ITEM	MATERIAL	CONDITION	Leaks (gpm)	DEFECTS
FRAME	CAST	2		Chipped
CORBEL	BRICK	1		
STEPS	PLASTIC	1		
WALLS	PRECAST	1		
FLOOR	BRICK	1		
INVERT	BRICK	1

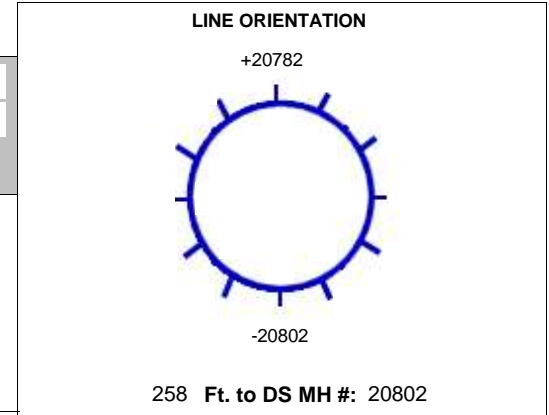
Municipality:	Hull, MA	Manhole No.:	20787
Street:	7 Andrew Road	Sub-System:	4
Inspection Date:	5/4/2020	Inspector:	MA
		Map #:

Cracked pavement surrounding frame

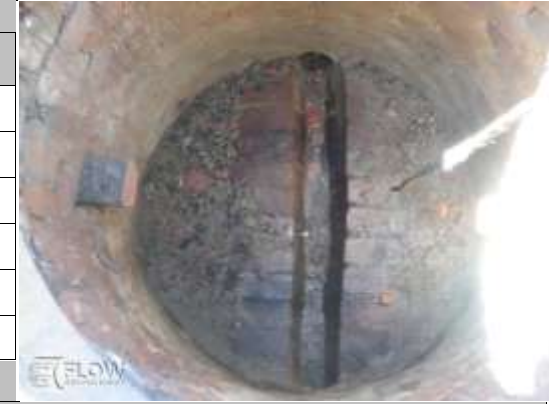
ITEM	MATERIAL	CONDITION	Leaks (gpm)	DEFECTS
FRAME	CAST	1		
CORBEL	BRICK	2		Deteriorating brick
STEPS	BRICK	1		
WALLS	BRICK	1		
FLOOR	BRICK	1		
INVERT	BRICK	1

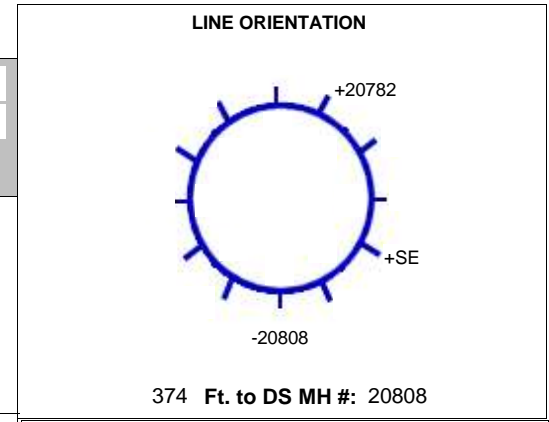
Municipality:	Hull, MA	Manhole No.:	20788
Street:	45 Hampton Circle	Sub-System:	4
Inspection Date:	5/4/2020	Inspector:	MA
		Map #:

Cracked and missing pavement surrounding frame

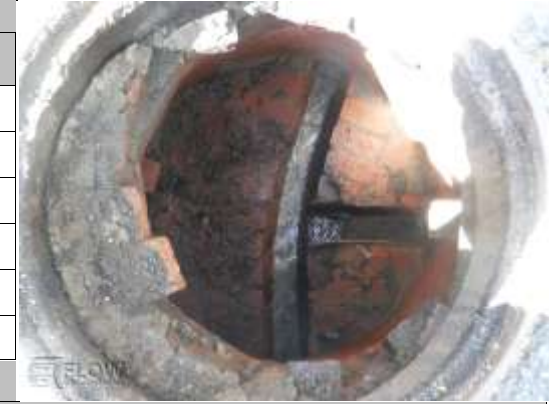
ITEM	MATERIAL	CONDITION	Leaks (gpm)	DEFECTS
FRAME	CAST	1		
CORBEL	BRICK	3		Loose brick, Offset 5"
STEPS	BRICK	1		
WALLS	BRICK	1		
FLOOR	BRICK	1		
INVERT	BRICK	1

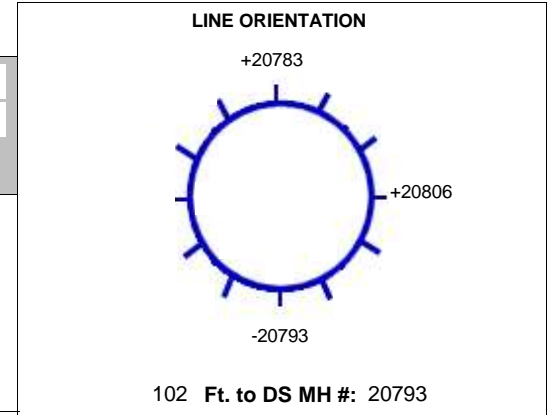
Municipality:	Hull, MA	Manhole No.:	20789
Street:	Fairmount Way and Hillside Road	Sub-System:	4
Inspection Date:	4/30/2020	Inspector:	MA
		Map #:

Cracked and missing pavement surrounding frame

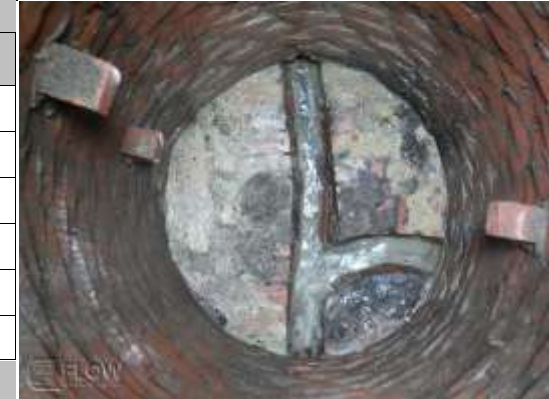
ITEM	MATERIAL	CONDITION	Leaks (gpm)	DEFECTS
FRAME	CAST	2		Chipped
CORBEL	BRICK	1		
STEPS	BRICK	1		
WALLS	BRICK	2		Staining
FLOOR	BRICK	1		
INVERT	BRICK	1

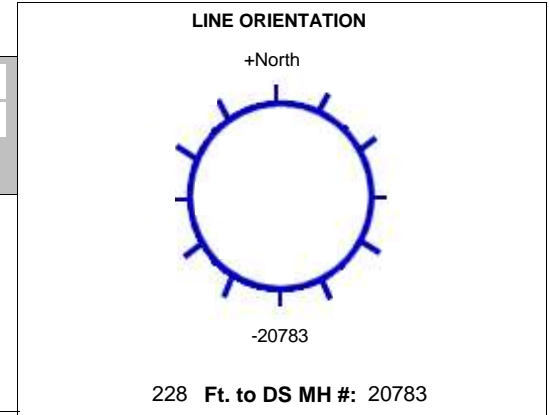
Municipality:	Hull, MA	Manhole No.:	20797
Street:	28 Roosevelt Avenue	Sub-System:	4
Inspection Date:	4/30/2020	Inspector:	MA
		Map #:

Cracked pavement surrounding frame

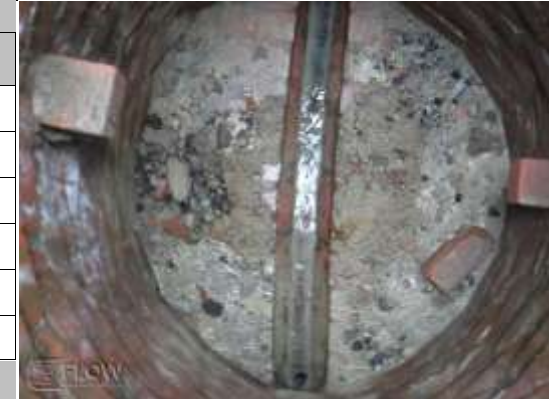
ITEM	MATERIAL	CONDITION	Leaks (gpm)	DEFECTS
FRAME	CAST	1		
CORBEL	BRICK	1		
STEPS	BRICK	1		
WALLS	BRICK	2		Staining
FLOOR	BRICK	1		
INVERT	BRICK	1

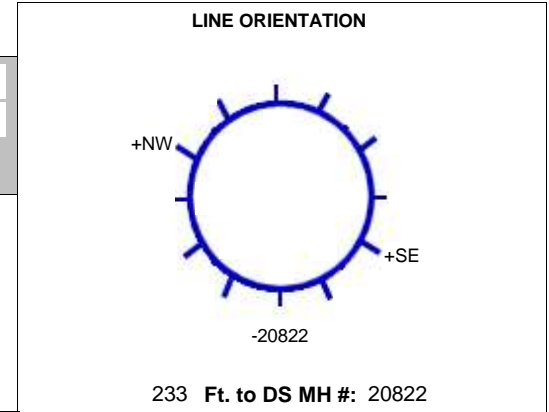
Cracked pavement surrounding frame

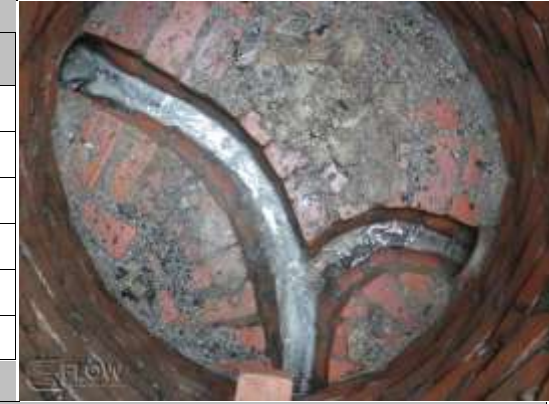
ITEM	MATERIAL	CONDITION	Leaks (gpm)	DEFECTS
FRAME	CAST	1		
CORBEL	BRICK	2		Missing mortar
STEPS	BRICK	1		
WALLS	BRICK	1		
FLOOR	BRICK	1		
INVERT	BRICK	1

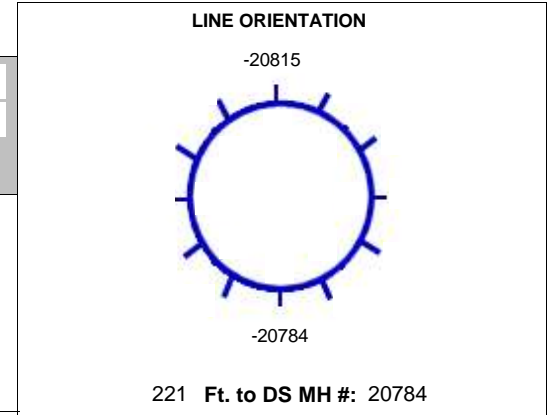
Municipality:	Hull, MA	Manhole No.:	20799
Street:	31 Merrill Road	Sub-System:	4
Inspection Date:	4/30/2020	Inspector:	MA
		Map #:

Cracked pavement surrounding frame

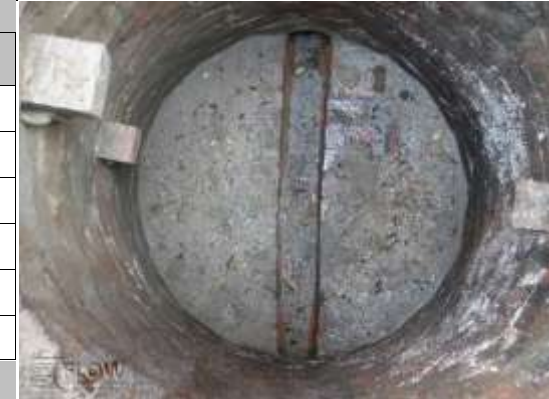
ITEM	MATERIAL	CONDITION	Leaks (gpm)	DEFECTS
FRAME	CAST	1		
CORBEL	BRICK	2		Missing mortar
STEPS	BRICK	1		
WALLS	BRICK	3	0.1	Dripping infiltration
FLOOR	BRICK	1		
INVERT	BRICK	1

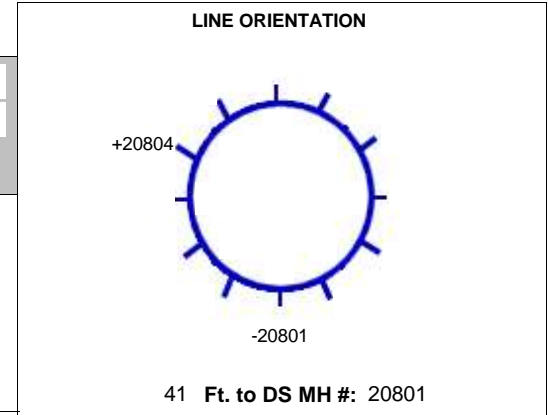
Municipality:	Hull, MA	Manhole No.:	20800
Street:	Porrazzo Road and Bay Street	Sub-System:	4
Inspection Date:	4/30/2020	Inspector:	MA
		Map #:

Cracked pavement surrounding frame

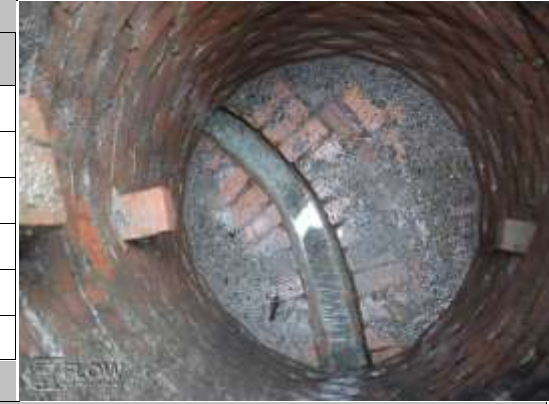
ITEM	MATERIAL	CONDITION	Leaks (gpm)	DEFECTS
FRAME	CAST	1		
CORBEL	BRICK	2		Loose brick
STEPS	BRICK	1		
WALLS	BRICK	3	0.1	Weeping infiltration
FLOOR	BRICK	2		Missing mortar
INVERT	BRICK	1

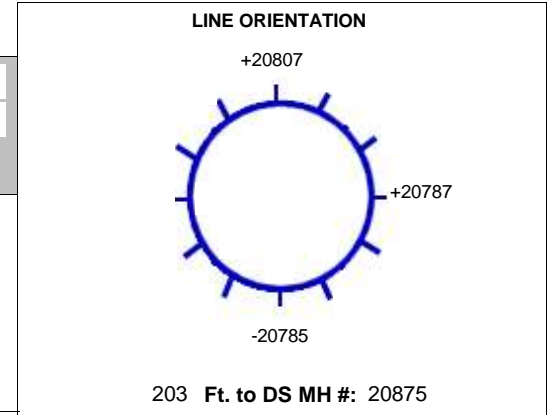
Municipality:	Hull, MA	Manhole No.:	20802
Street:	15 Hampton Circle	Sub-System:	4
Inspection Date:	5/4/2020	Inspector:	MA
		Map #:

Cracked pavement surrounding frame

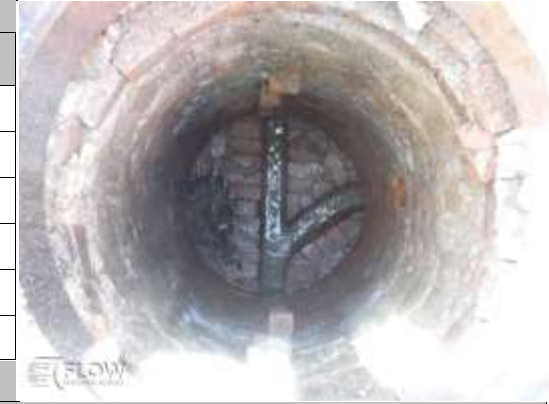
ITEM	MATERIAL	CONDITION	Leaks (gpm)	DEFECTS
FRAME	CAST	1		
CORBEL	BRICK	3	0.1	Missing mortar, Weeping infiltration
STEPS	BRICK	1		
WALLS	BRICK	1		
FLOOR	BRICK	1		
INVERT	BRICK	1

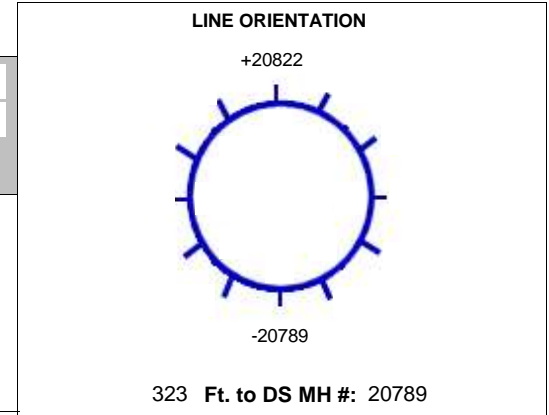
Municipality:	Hull, MA	Manhole No.:	20806
Street:	10 Hillside Road	Sub-System:	4
Inspection Date:	4/30/2020	Inspector:	MA
		Map #:

Cracked and missing pavement surrounding frame

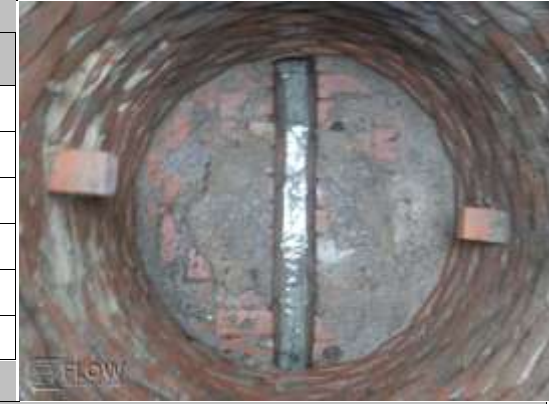
ITEM	MATERIAL	CONDITION	Leaks (gpm)	DEFECTS
FRAME	CAST	1		
CORBEL	BRICK	2		Missing mortar
STEPS	BRICK	1		
WALLS	BRICK	1		
FLOOR	BRICK	1		
INVERT	BRICK	1

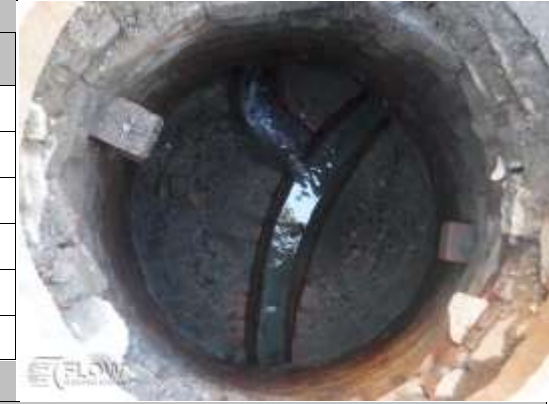
ITEM	MATERIAL	CONDITION	Leaks (gpm)	DEFECTS
FRAME	CAST	1		
CORBEL	BRICK	2		Missing mortar
STEPS	BRICK	1		
WALLS	BRICK	1		
FLOOR	BRICK	1		
INVERT	BRICK	1

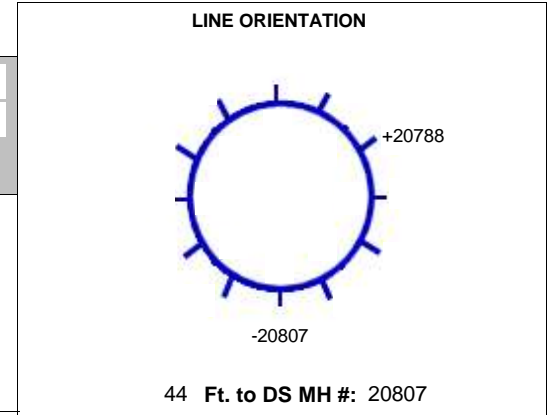
Municipality:	Hull, MA	Manhole No.:	20808
Street:	31 Hampton Circle	Sub-System:	4
Inspection Date:	5/4/2020	Inspector:	MA
		Map #:

Cracked pavement surrounding frame

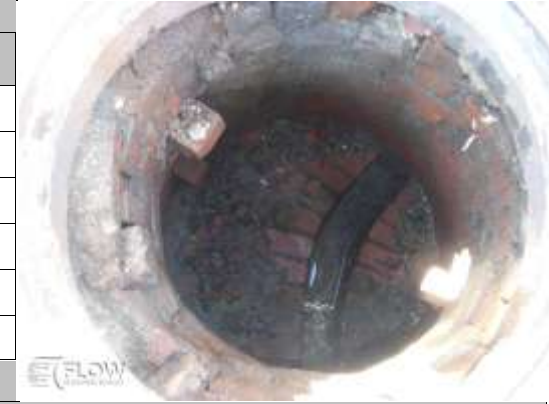
ITEM	MATERIAL	CONDITION	Leaks (gpm)	DEFECTS
FRAME	CAST	1		
CORBEL	BRICK	2		Missing brick
STEPS	BRICK	1		
WALLS	BRICK	1		
FLOOR	BRICK	1		
INVERT	BRICK	1

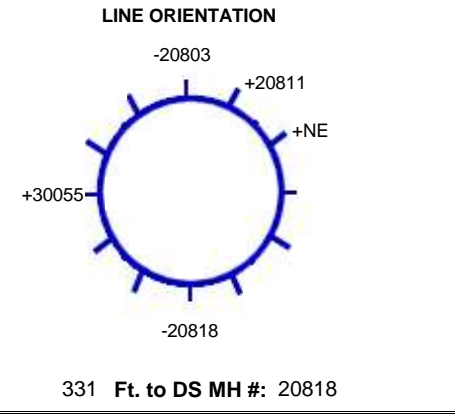
Municipality: Hull, MA  
 Street: Nantasket Avenue and Bay Street  
 Inspection Date: 4/30/2020 Inspector: MA Map #:   
 Manhole No.: 20810  
 Sub-System: 4

Cracked pavement surrounding frame

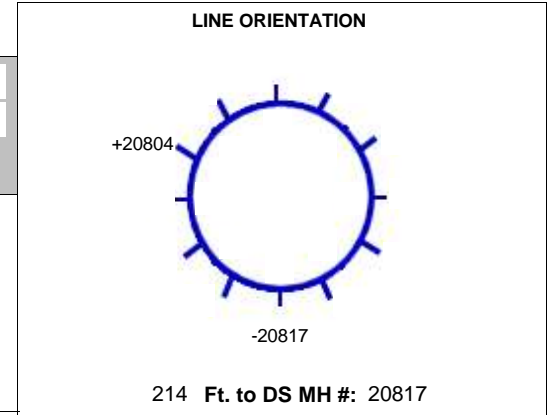
Municipality:	Hull, MA	Manhole No.:	20812
Street:	31 Sagamore Terrace	Sub-System:	4
Inspection Date:	4/30/2020	Inspector:	MA
		Map #:

Cracked pavement surrounding frame

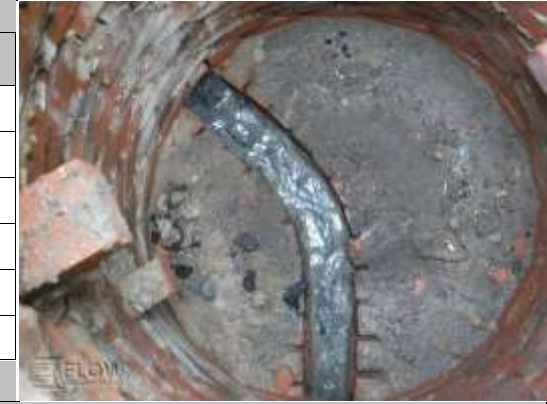
ITEM	MATERIAL	CONDITION	Leaks (gpm)	DEFECTS
FRAME	CAST	1		
CORBEL	BRICK	2		Missing mortar
STEPS	BRICK	1		
WALLS	BRICK	1		
FLOOR	BRICK	2		Missing mortar
INVERT	BRICK	1

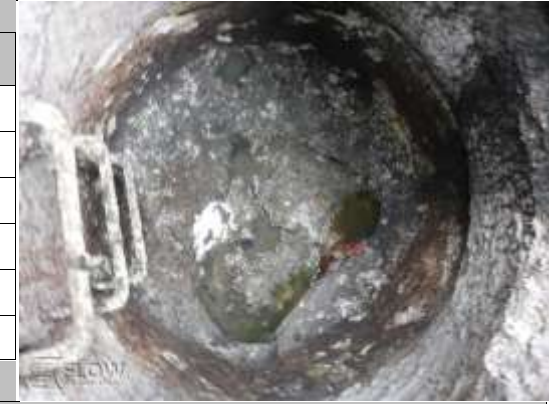
ITEM	MATERIAL	CONDITION	Leaks (gpm)	DEFECTS
FRAME	CAST	1		
CORBEL	BRICK	2		Missing mortar
STEPS	ALUM	1		
WALLS	PRECAST	3		Mineral deposits
FLOOR	CNI	0		Surcharged
INVERT	CNI	0		Surcharged

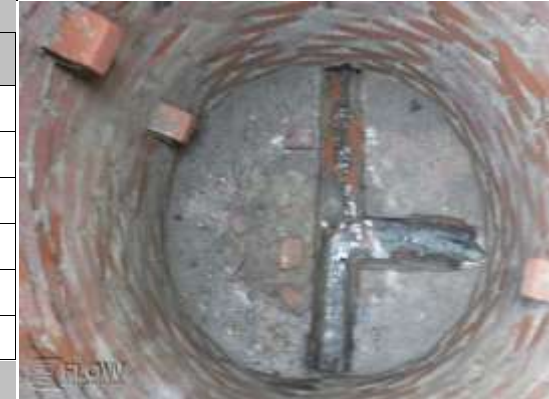
ITEM	MATERIAL	CONDITION	Leaks (gpm)	DEFECTS
FRAME	CAST	1		
CORBEL	BRICK	4		Missing brick, Missing mortar
STEPS	BRICK	1		
WALLS	BRICK	1		
FLOOR	BRICK	1		
INVERT	BRICK	1

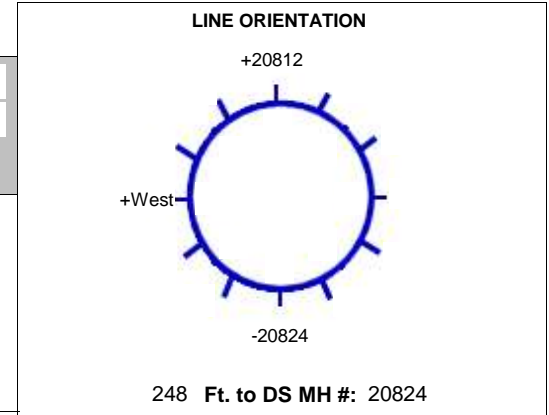
Municipality:	Hull, MA	Manhole No.:	20817
Street:	3 Sagamore Terrace	Sub-System:	4
Inspection Date:	4/30/2020	Inspector:	MA
		Map #:

Cracked pavement surrounding frame

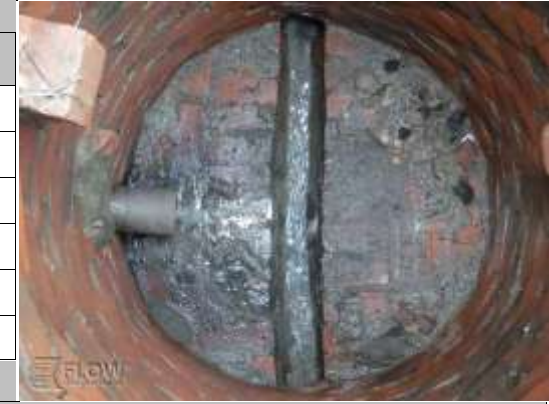
ITEM	MATERIAL	CONDITION	Leaks (gpm)	DEFECTS
FRAME	CAST	1		
CORBEL	BRICK	2		Missing mortar
STEPS	BRICK	3		Broken
WALLS	BRICK	1		
FLOOR	BRICK	1		
INVERT	BRICK	1

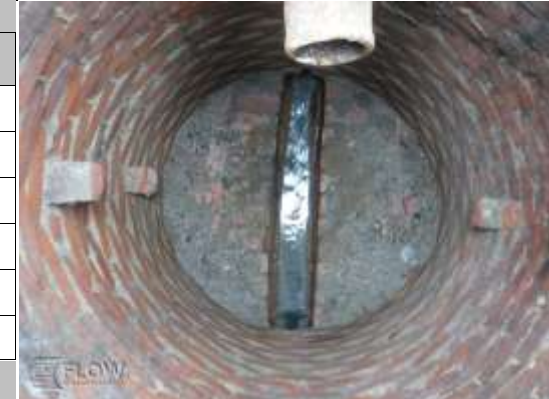
ITEM	MATERIAL	CONDITION	Leaks (gpm)	DEFECTS
FRAME	CAST	1		
CORBEL	BRICK	1		
STEPS	BRICK	3		Broken
WALLS	BRICK	1		
FLOOR	BRICK	1		
INVERT	BRICK	1

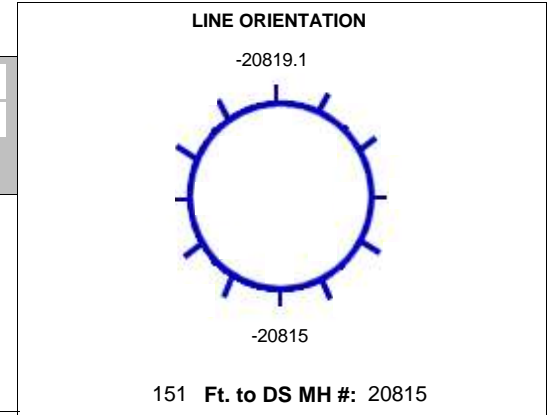
Municipality:	Hull, MA	Manhole No.:	20819
Street:	Porrazzo Road	Sub-System:	4
Inspection Date:	4/30/2020	Inspector:	MA
		Map #:

Cracked and missing pavement surrounding frame

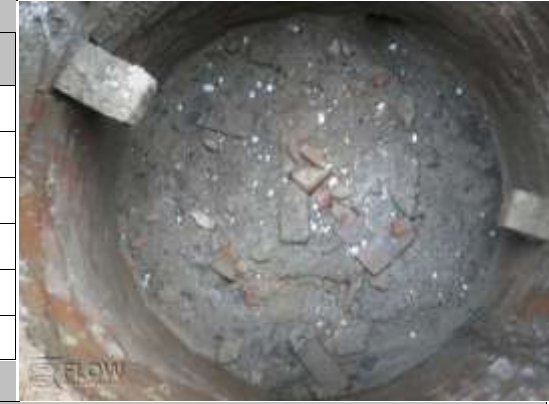
ITEM	MATERIAL	CONDITION	Leaks (gpm)	DEFECTS
FRAME	CAST	1		
CORBEL	BRICK	5		Missing brick and missing mortar
STEPS	BRICK	1		
WALLS	BRICK	1		
FLOOR	CNI	0		Covered in debris
INVERT	CNI	0		Covered in debris

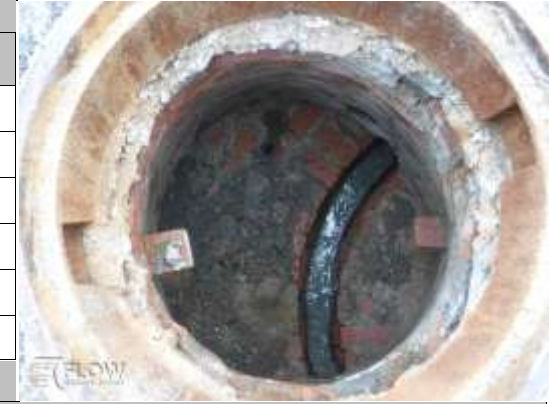
ITEM	MATERIAL	CONDITION	Leaks (gpm)	DEFECTS
FRAME	CAST	1		
CORBEL	BRICK	1		
STEPS	BRICK	1		
WALLS	BRICK	1		
FLOOR	BRICK	1		
INVERT	BRICK	2		Missing mortar

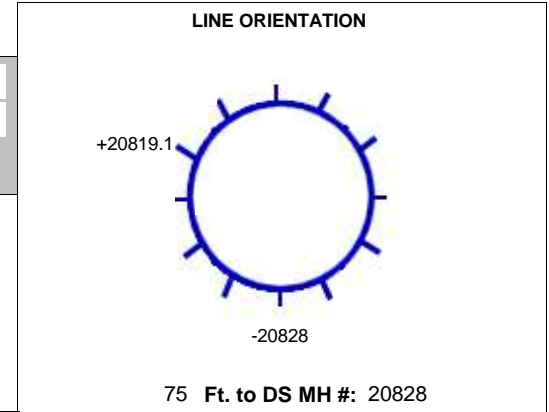
Cracked pavement surrounding frame, Manhole not on map

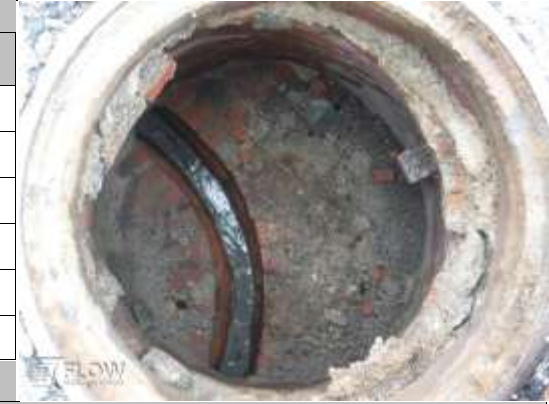
ITEM	MATERIAL	CONDITION	Leaks (gpm)	DEFECTS
FRAME	CAST	1		
CORBEL	BRICK	2		Missing mortar
STEPS	BRICK	1		
WALLS	BRICK	1		
FLOOR	BRICK	1		
INVERT	BRICK	1

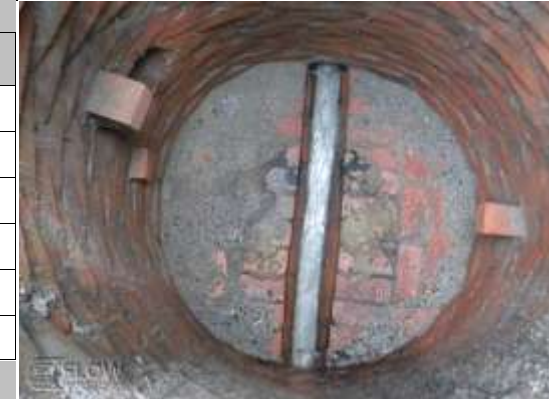
ITEM	MATERIAL	CONDITION	Leaks (gpm)	DEFECTS
FRAME	CAST	1		
CORBEL	BRICK	4		Missing brick and missing mortar
STEPS	BRICK	1		
WALLS	BRICK	1		
FLOOR	BRICK	1		
INVERT	BRICK	1
