# Flow Assessment Services, LLC. Structure Inspection Log

Municipality:	Hull, MA	Manhole No.:	20696
Street:	40 Whitehead Avenue	Sub-System:	4
Inspection Date:	4/29/2020	Inspector:	MA
		Map #:

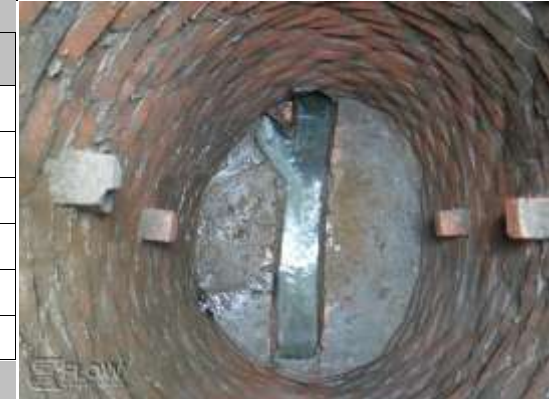
ITEM	MATERIAL	CONDITION	Leaks (gpm)	DEFECTS
FRAME	CAST	1		
CORBEL	BRICK	1		
STEPS	BRICK	2		Broken
WALLS	BRICK	3	0.1	Weeping infiltration
FLOOR	BRICK	2		Missing mortar
INVERT	BRICK	1

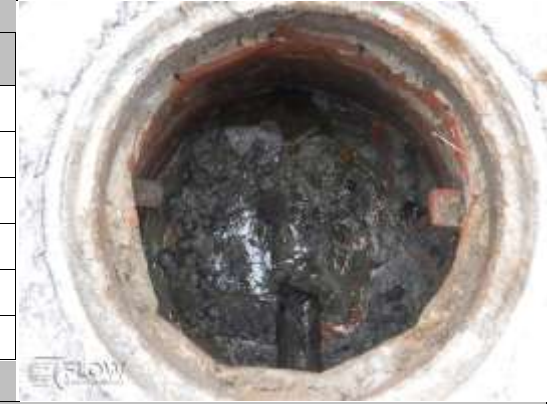
ITEM	MATERIAL	CONDITION	Leaks (gpm)	DEFECTS
FRAME	CAST	1		
CORBEL	BRICK	2		Missing mortar
STEPS	BRICK	1		
WALLS	BRICK	1		
FLOOR	BRICK	1		
INVERT	BRICK	1

Surcharge From Invert:  Currently: 3 Feet Marks To:  Feet

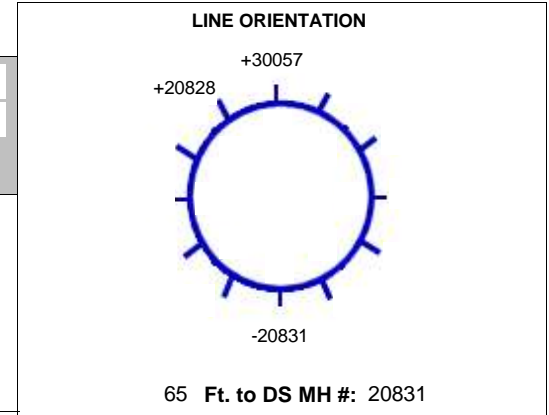
Municipality:	Hull, MA	Manhole No.:	20829
Street:	257 Nantasket Avenue	Sub-System:	4
Inspection Date:	4/30/2020	Inspector:	MA
		Map #:

Cracked pavement surrounding frame

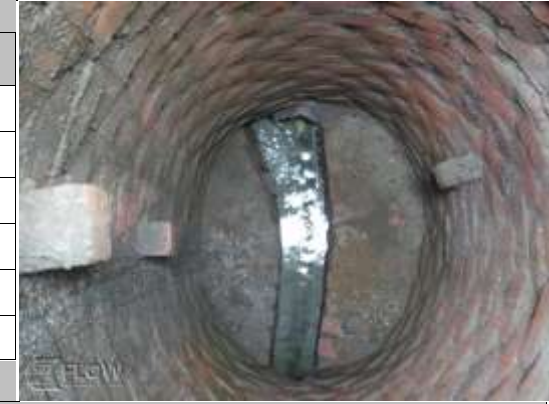
ITEM	MATERIAL	CONDITION	Leaks (gpm)	DEFECTS
FRAME	CAST	1		
CORBEL	BRICK	1		
STEPS	BRICK	3		Broken
WALLS	BRICK	1		
FLOOR	BRICK	2		Missing mortar
INVERT	BRICK	1

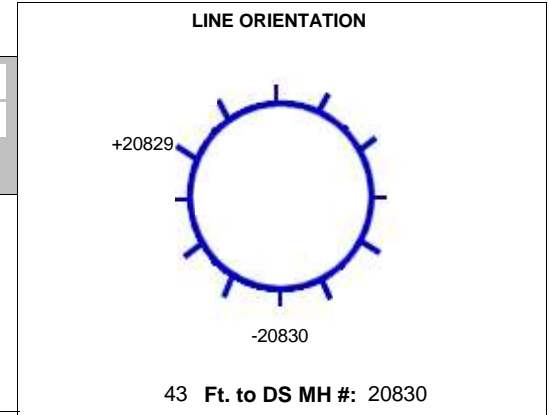
<b>Municipality:</b>	Hull, MA	<b>Manhole No.:</b>	20831
<b>Street:</b>	Nantasket Avenue and George Washington Blvd.	<b>Sub-System:</b>	4
<b>Inspection Date:</b>	4/30/2020	<b>Inspector:</b>	MA
		<b>Map #:</b>

Cracked pavement surrounding frame

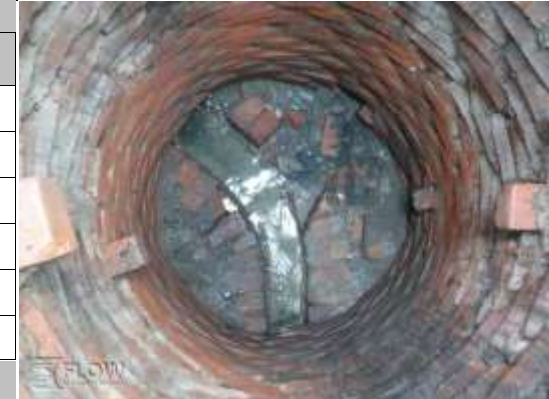
ITEM	MATERIAL	CONDITION	Leaks (gpm)	DEFECTS
FRAME	CAST	1		
CORBEL	BRICK	1		
STEPS	BRICK	1		
WALLS	BRICK	4		Missing bricks
FLOOR	BRICK	2		Missing mortar
INVERT	BRICK	2		Missing mortar

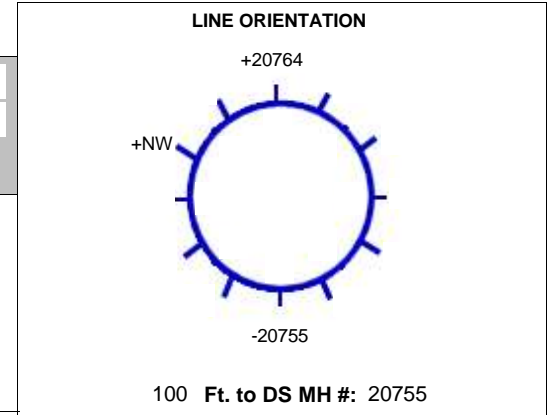
Municipality:	Hull, MA	Manhole No.:	30052
Street:	105 Bay Street	Sub-System:	4
Inspection Date:	4/30/2020	Inspector:	MA
		Map #:

Cracked and missing pavement surrounding frame

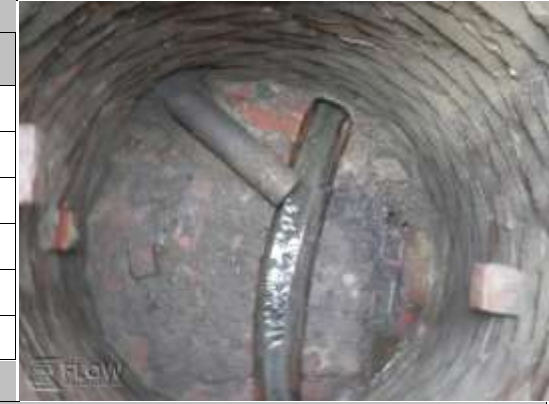
ITEM	MATERIAL	CONDITION	Leaks (gpm)	DEFECTS
FRAME	CAST	2		Chipped
CORBEL	BRICK	1		
STEPS	BRICK	1		
WALLS	BRICK	1		
FLOOR	BRICK	1		
INVERT	BRICK	1

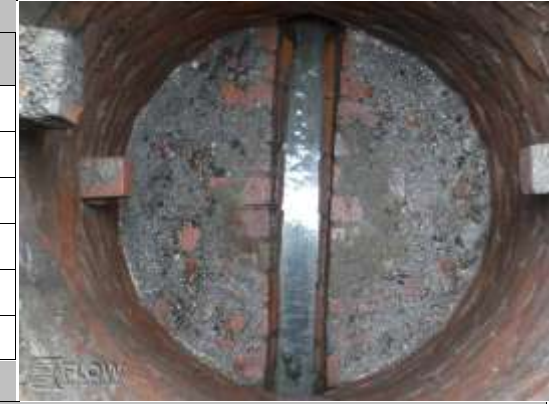
ITEM	MATERIAL	CONDITION	Leaks (gpm)	DEFECTS
FRAME	CAST	1		
CORBEL	BRICK	1		
STEPS	BRICK	1		
WALLS	BRICK	1		
FLOOR	BRICK	1		
INVERT	BRICK	1

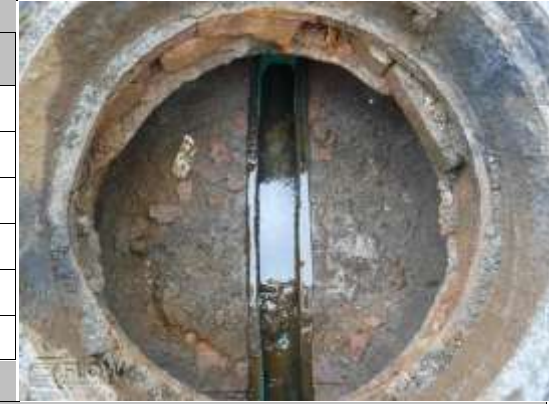
ITEM	MATERIAL	CONDITION	Leaks (gpm)	DEFECTS
FRAME	CAST	2		Chipped
CORBEL	BRICK	1		
STEPS	NONE	0		
WALLS	PRECAST	1		
FLOOR	BRICK	1		
INVERT	PVC	4	0.1	Running infiltration
