# ROAD SAFETY AUDIT

Route 9 (Boylston Street) at  
Elliot Street, Woodward Street, Glenmore Terrace and  
Ramsdell Street

City of Newton

April 23, 2021

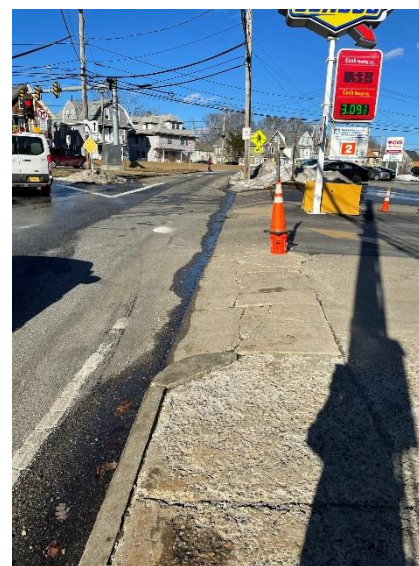
- Sidewalks are in poor condition at the intersection. This is especially the case for the sidewalk on the east side of Elliot Street and the east side of Woodward Street. Sidewalk panels are broken, and multiple obstructions (utility poles) are located within the pedestrian clear path.
- Crosswalks at the intersection consist of two transverse lines and lack hatching for higher visibility of the crosswalk. In addition, the crosswalk across the Elliot Street right-turn lane (continental style) does not match the other five crosswalk locations.

**Image 1: Poor Sidewalk Conditions (East side of Elliot Street)**

- Reconstructing sidewalks on Elliot Street and Woodward Street and maintaining consistent clear zone meeting ADA and AAB guidelines.
- Restriping all crosswalks, including the crosswalk across the Elliot Street channelized right-turn lane, with high visibility markings to increase conspicuousness and awareness. High visibility markings can be applied to existing crosswalk and include “Ladder” type crosswalk hatching for improved safety.

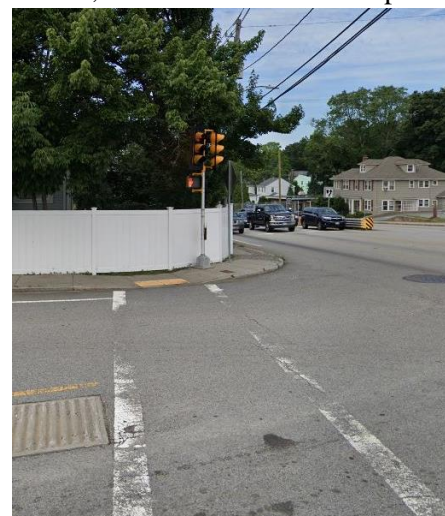
- A fence on the southwest corner of the intersection blocks visibility of the pedestrians on the sidewalk, waiting to cross Elliot Street. The fence is located at the back of the sidewalk and obstructs the visibility of right-turning vehicles from seeing pedestrians waiting to cross.

**Image 2: Fence Blocks Visibility on the Southwest Corner**

- Widen the curb radius along with sidewalk on the southwest corner of the intersection. This would provide more visibility of pedestrians on the sidewalk, while also requiring right-turning vehicles

to slow down to complete the turning movement. Turning movements for larger trucks and emergency vehicles should be verified as part of this enhancement.

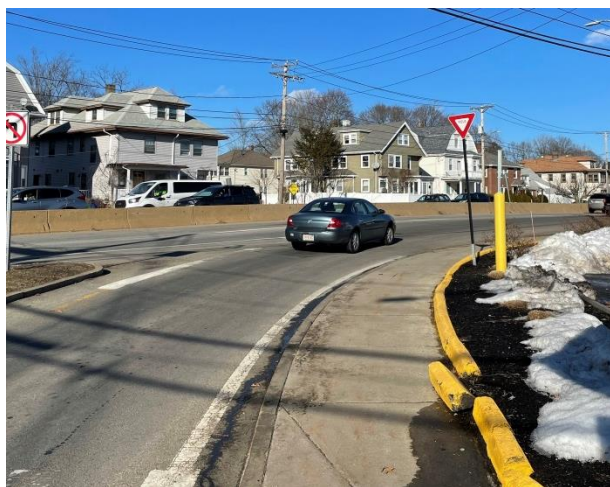
- The lack of signage and striping for the wide pavement width between Elliot Street and Ramsdell Street results in driver confusion, aggression and frustration for right-turning vehicles from Elliot Street. Merge movements into Route 9 eastbound traffic creates queues on this approach and often leads to honking and impatience of drivers waiting in the queue.
- The Yield sign for the channelized right-turn lane is substandard in size and appears to be mounted higher than the standard height. No pavement markings for the yield control (“shark teeth”) exist.

**Image 3: Substandard Yield Sign and lack of pavement markings**

• Consider replacing Yield signage with proper signage (size and mounting height) and new pavement markings for yield line “shark teeth” to provide better visibility of the yield control.
-

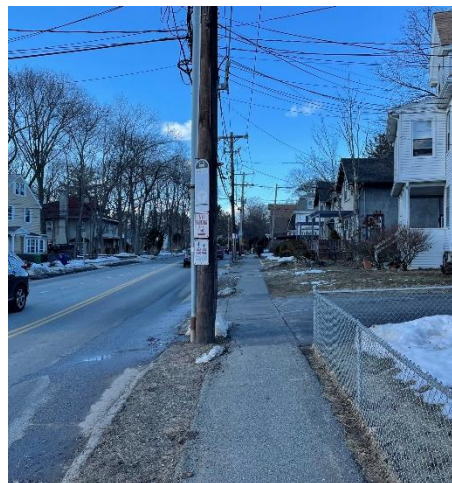
- Verify whether the bus shelter provided on the south side of Route 9 between Elliot Street and Ramsdell Road is active. If this shelter is active, a bus stopping there could block the visibility of vehicles attempting to enter Route 9 eastbound from Elliot Street as well as vehicles exiting from the Plaza driveway and Ramsdell Street.
- Currently Bus Route 59A only provides a far-side bus stop for the northbound direction. It was noted during the audit that a far-side stop on Elliot Street is preferred for the southbound direction to reduce impacts to intersection operations.
- The bus stop on the east side of Woodward Street is not an accessible location. The stop location does not provide the

**Image 4: Non-accessible bus stop on Woodward Street**

necessary continuous sidewalk width required. Currently a grass strip between the sidewalk and roadway exists and does not allow for the proper boarding and alighting of buses.

- Consider relocating/improving existing bus stops on Woodward Street to meet accessibility requirements. Paving the grass strip provided for the northbound stop or relocating the stop further south, closer to the intersection could also be considered.

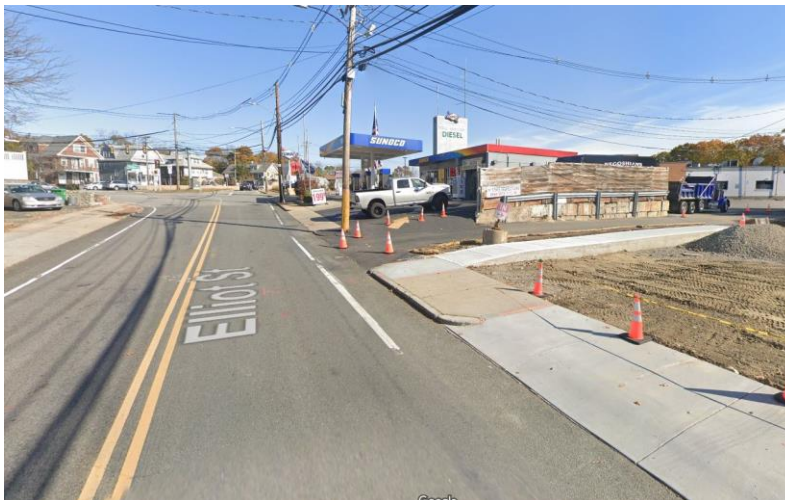
- Five commercial driveways exist along the east side of Elliot Street south of the intersection with Route 9: two Plaza driveways, two gas station driveways and one additional driveway for the proposed marijuana dispensary. These five driveways are all located within a span of 200 feet, with some driveways appearing to provide access to multiple properties, resulting in driver confusion as to which driveway corresponds to each property.

**Image 5: Five commercial driveways along Elliot Street**

- Consider consolidating driveways on Elliot Street to reduce the number of curb openings and conflicts with pedestrians. This would require discussions and negotiations with the private plaza property owners.
- Consider the closure of the southern Plaza entrance on Elliot Street.
- Coordinate driveway consolidation and Plaza circulations with property owners when any future redevelopment happens.
