# RECORD OF MEETING

**Client:** City of Taunton **Date:** 05/17/19  
**Meeting Date:** 05/17/19 **Prepared By:** Mike Andrus  
**Meeting Location:** Taunton DPW **Job Number:**  
**Meeting Topic:** Industrial Park Drainage

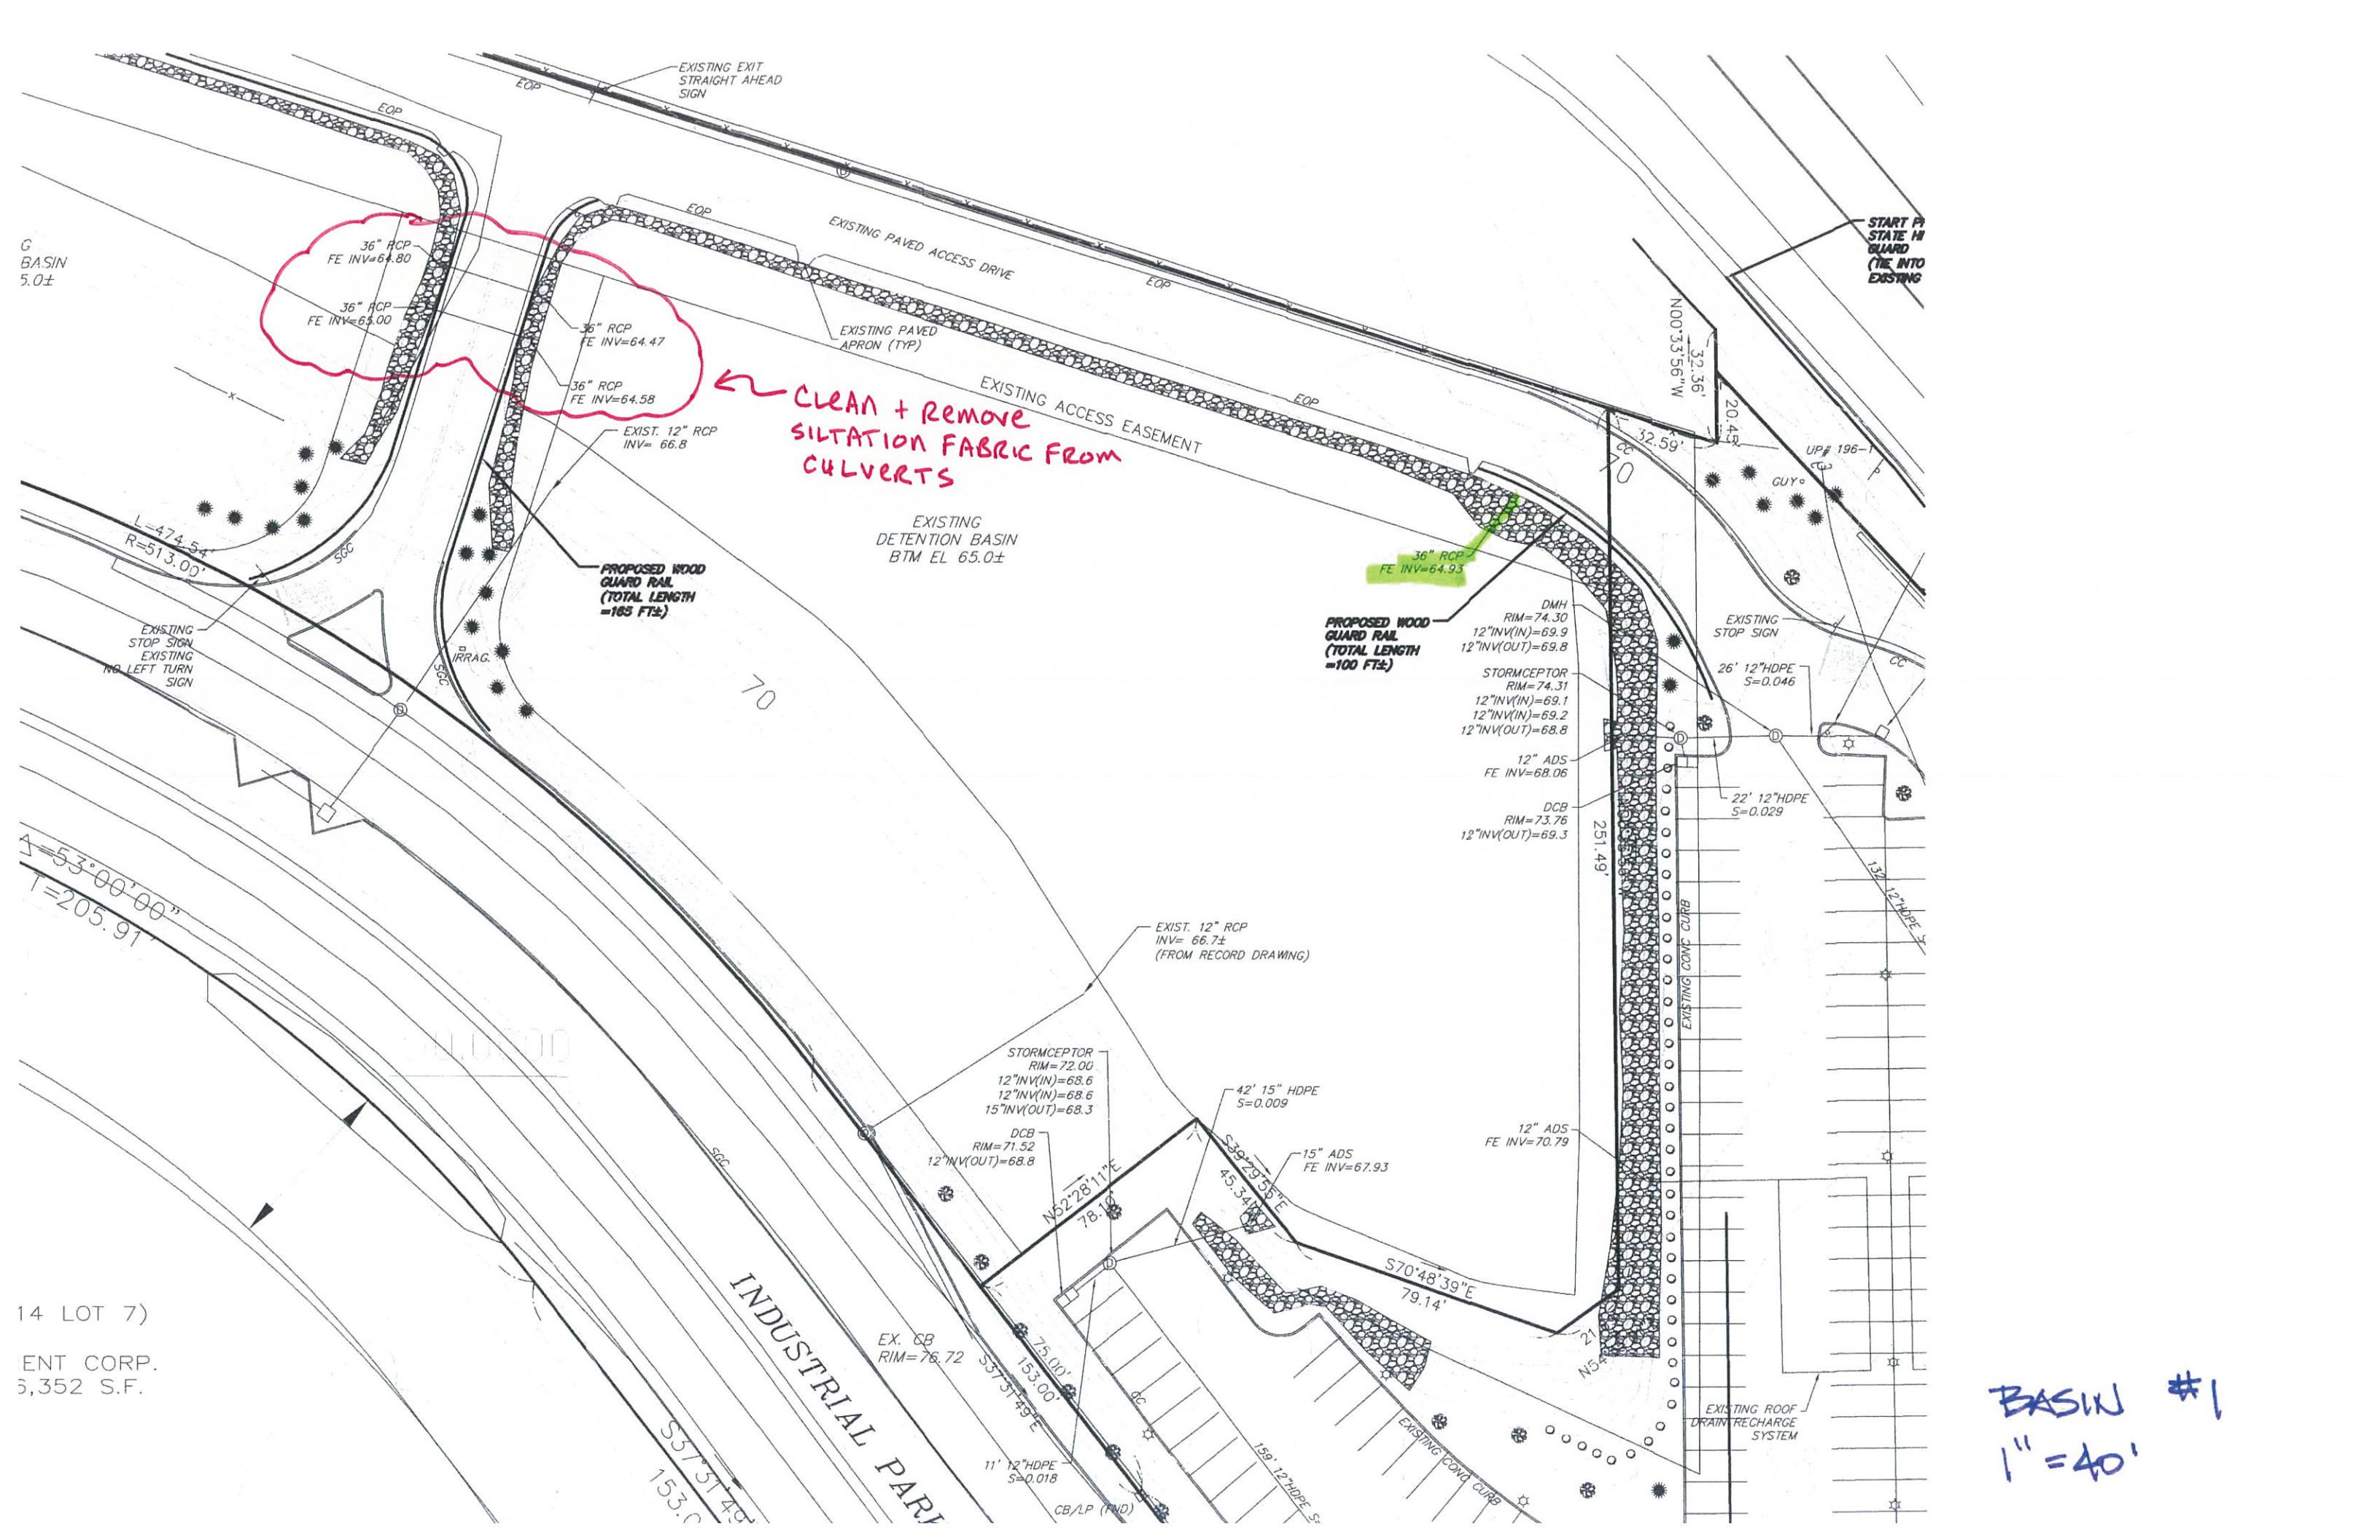
**BASIN #1  
1" = 40'**

- I. Basin #1 (off Myles Standish Blvd)
  - A. Clean out (esp. siltation fabric) culverts connecting two halves of the basin
- II. Basin #2 (off Constitution Dr)

**CLEAN + REMOVE  
SILTATION FABRIC FROM  
CULVERTS**

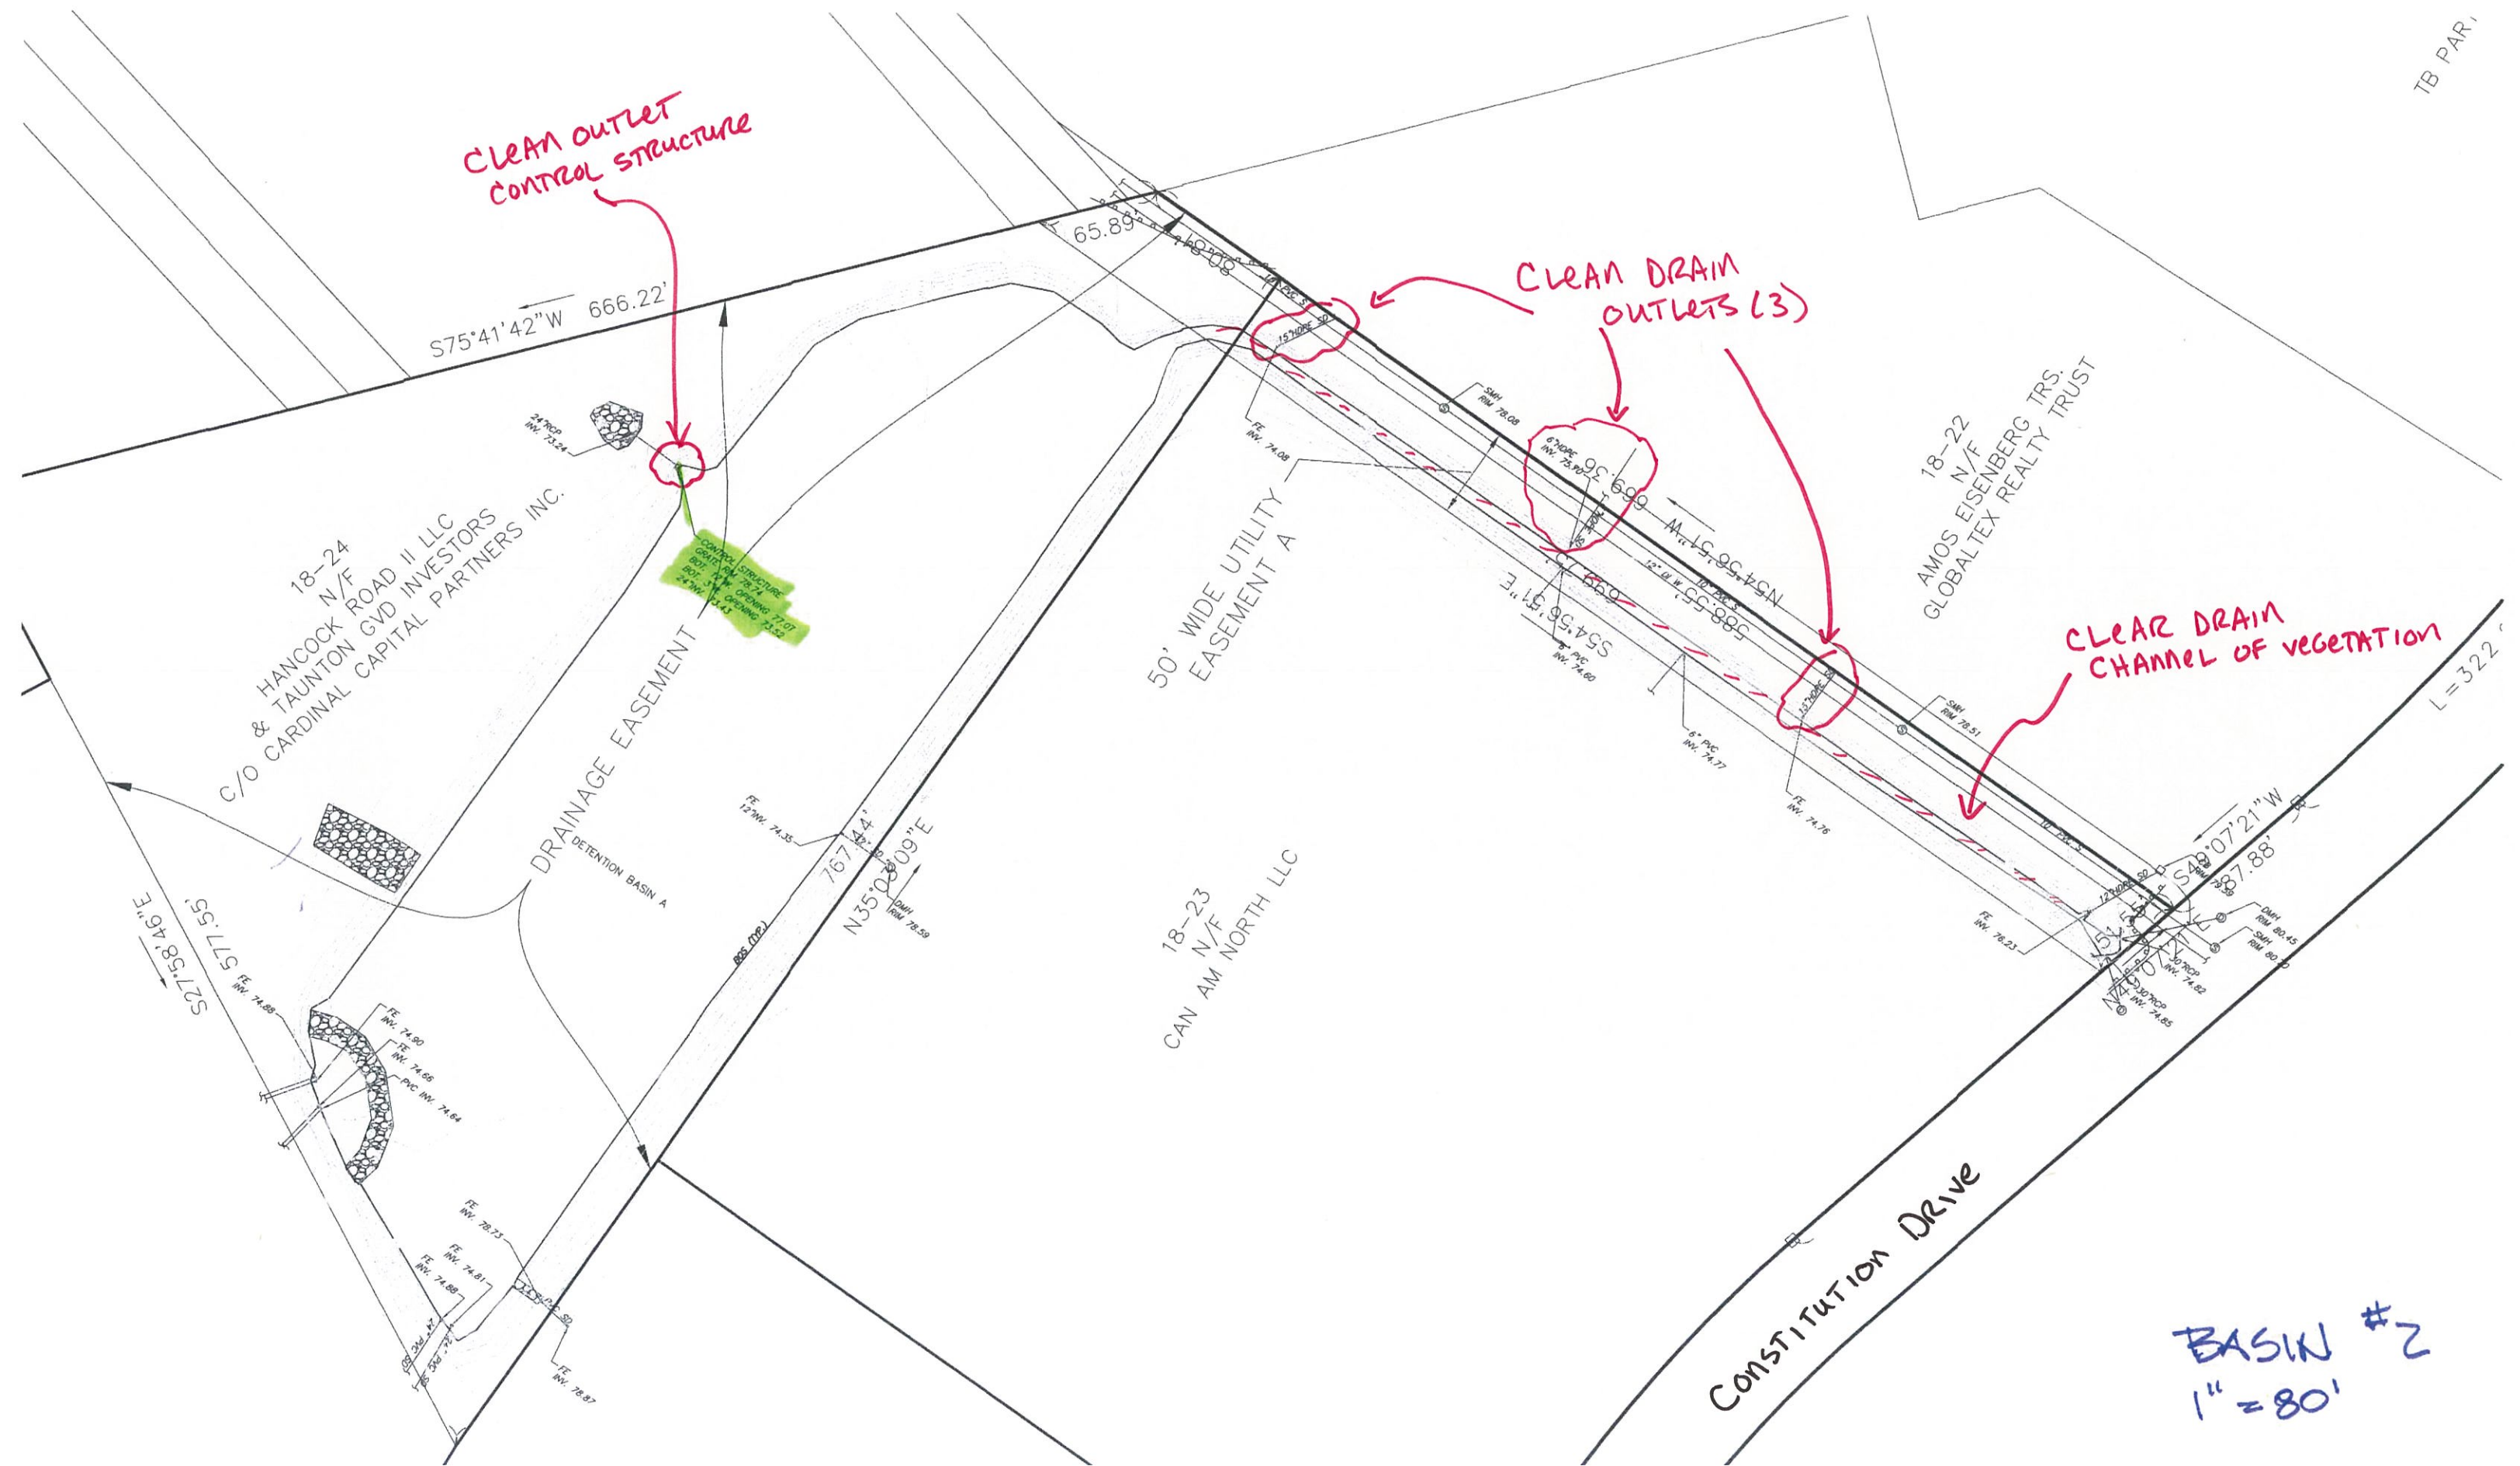
BASIN #2  
1" = 80'

- A. Channel between Constitution Drive and Basin #2 needs to be rid of vegetation
  - B. Clean drain outlets from Eisenberg property
  - C. Outlet control structure needs to be cleaned out (rack plugs with debris)

- D. Private culvert at #175 JQ Adams Rd needs cleaning (where TV was)
  - E. Channel exiting Basin #2 towards JQ Adams Rd needs cleaning and clearing (Is this a wetland? Michele)

CLEAN OUTLET  
CONTROL STRUCTURE

CLEAN DRAIN  
OUTLETS (3)

CLEAR DRAIN  
CHANNEL OF VEGETATION

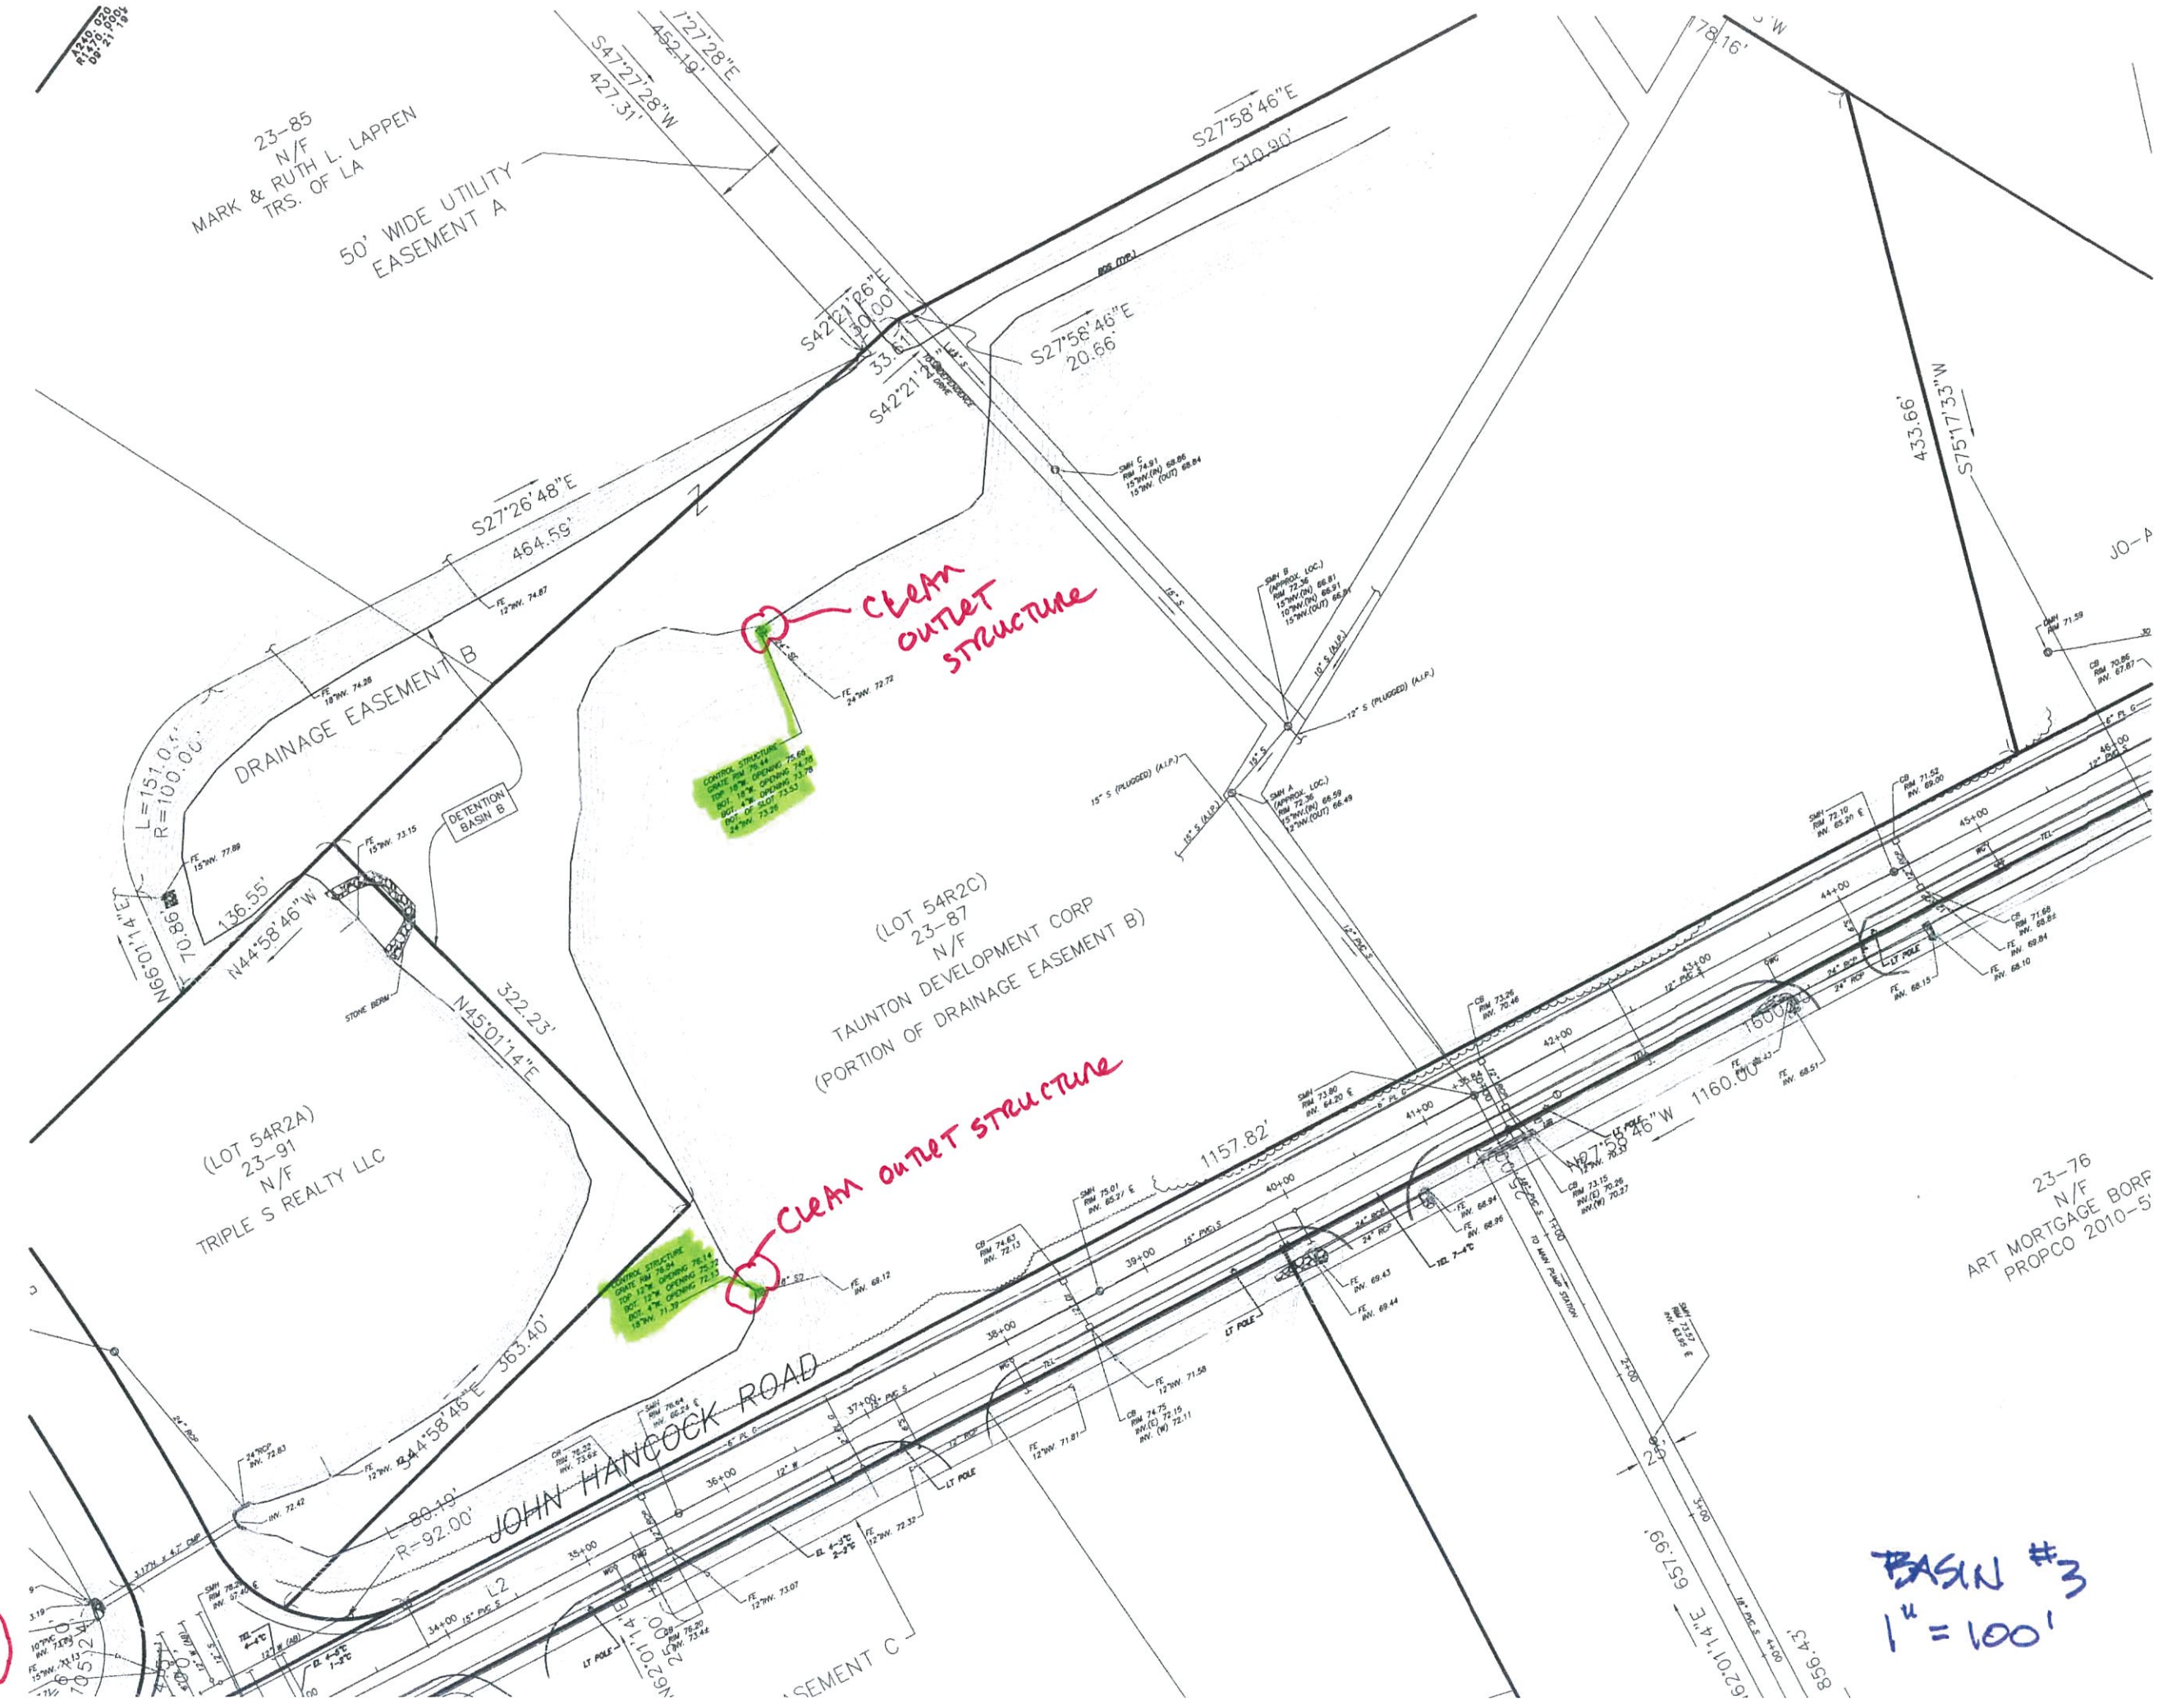
BASIN #3  
1" = 100'

- III. Basin #3 (John Hancock Rd)
  - A. Channel leading into Basin #3 is choked with vegetation and needs clearing
  - B. Both outlet structures are clogged with debris and need cleaning

CLEAR VEGETATION  
FROM CHANNEL  
UPSTREAM  
OF BASIN #3

CLEAN  
OUTLET  
STRUCTURE

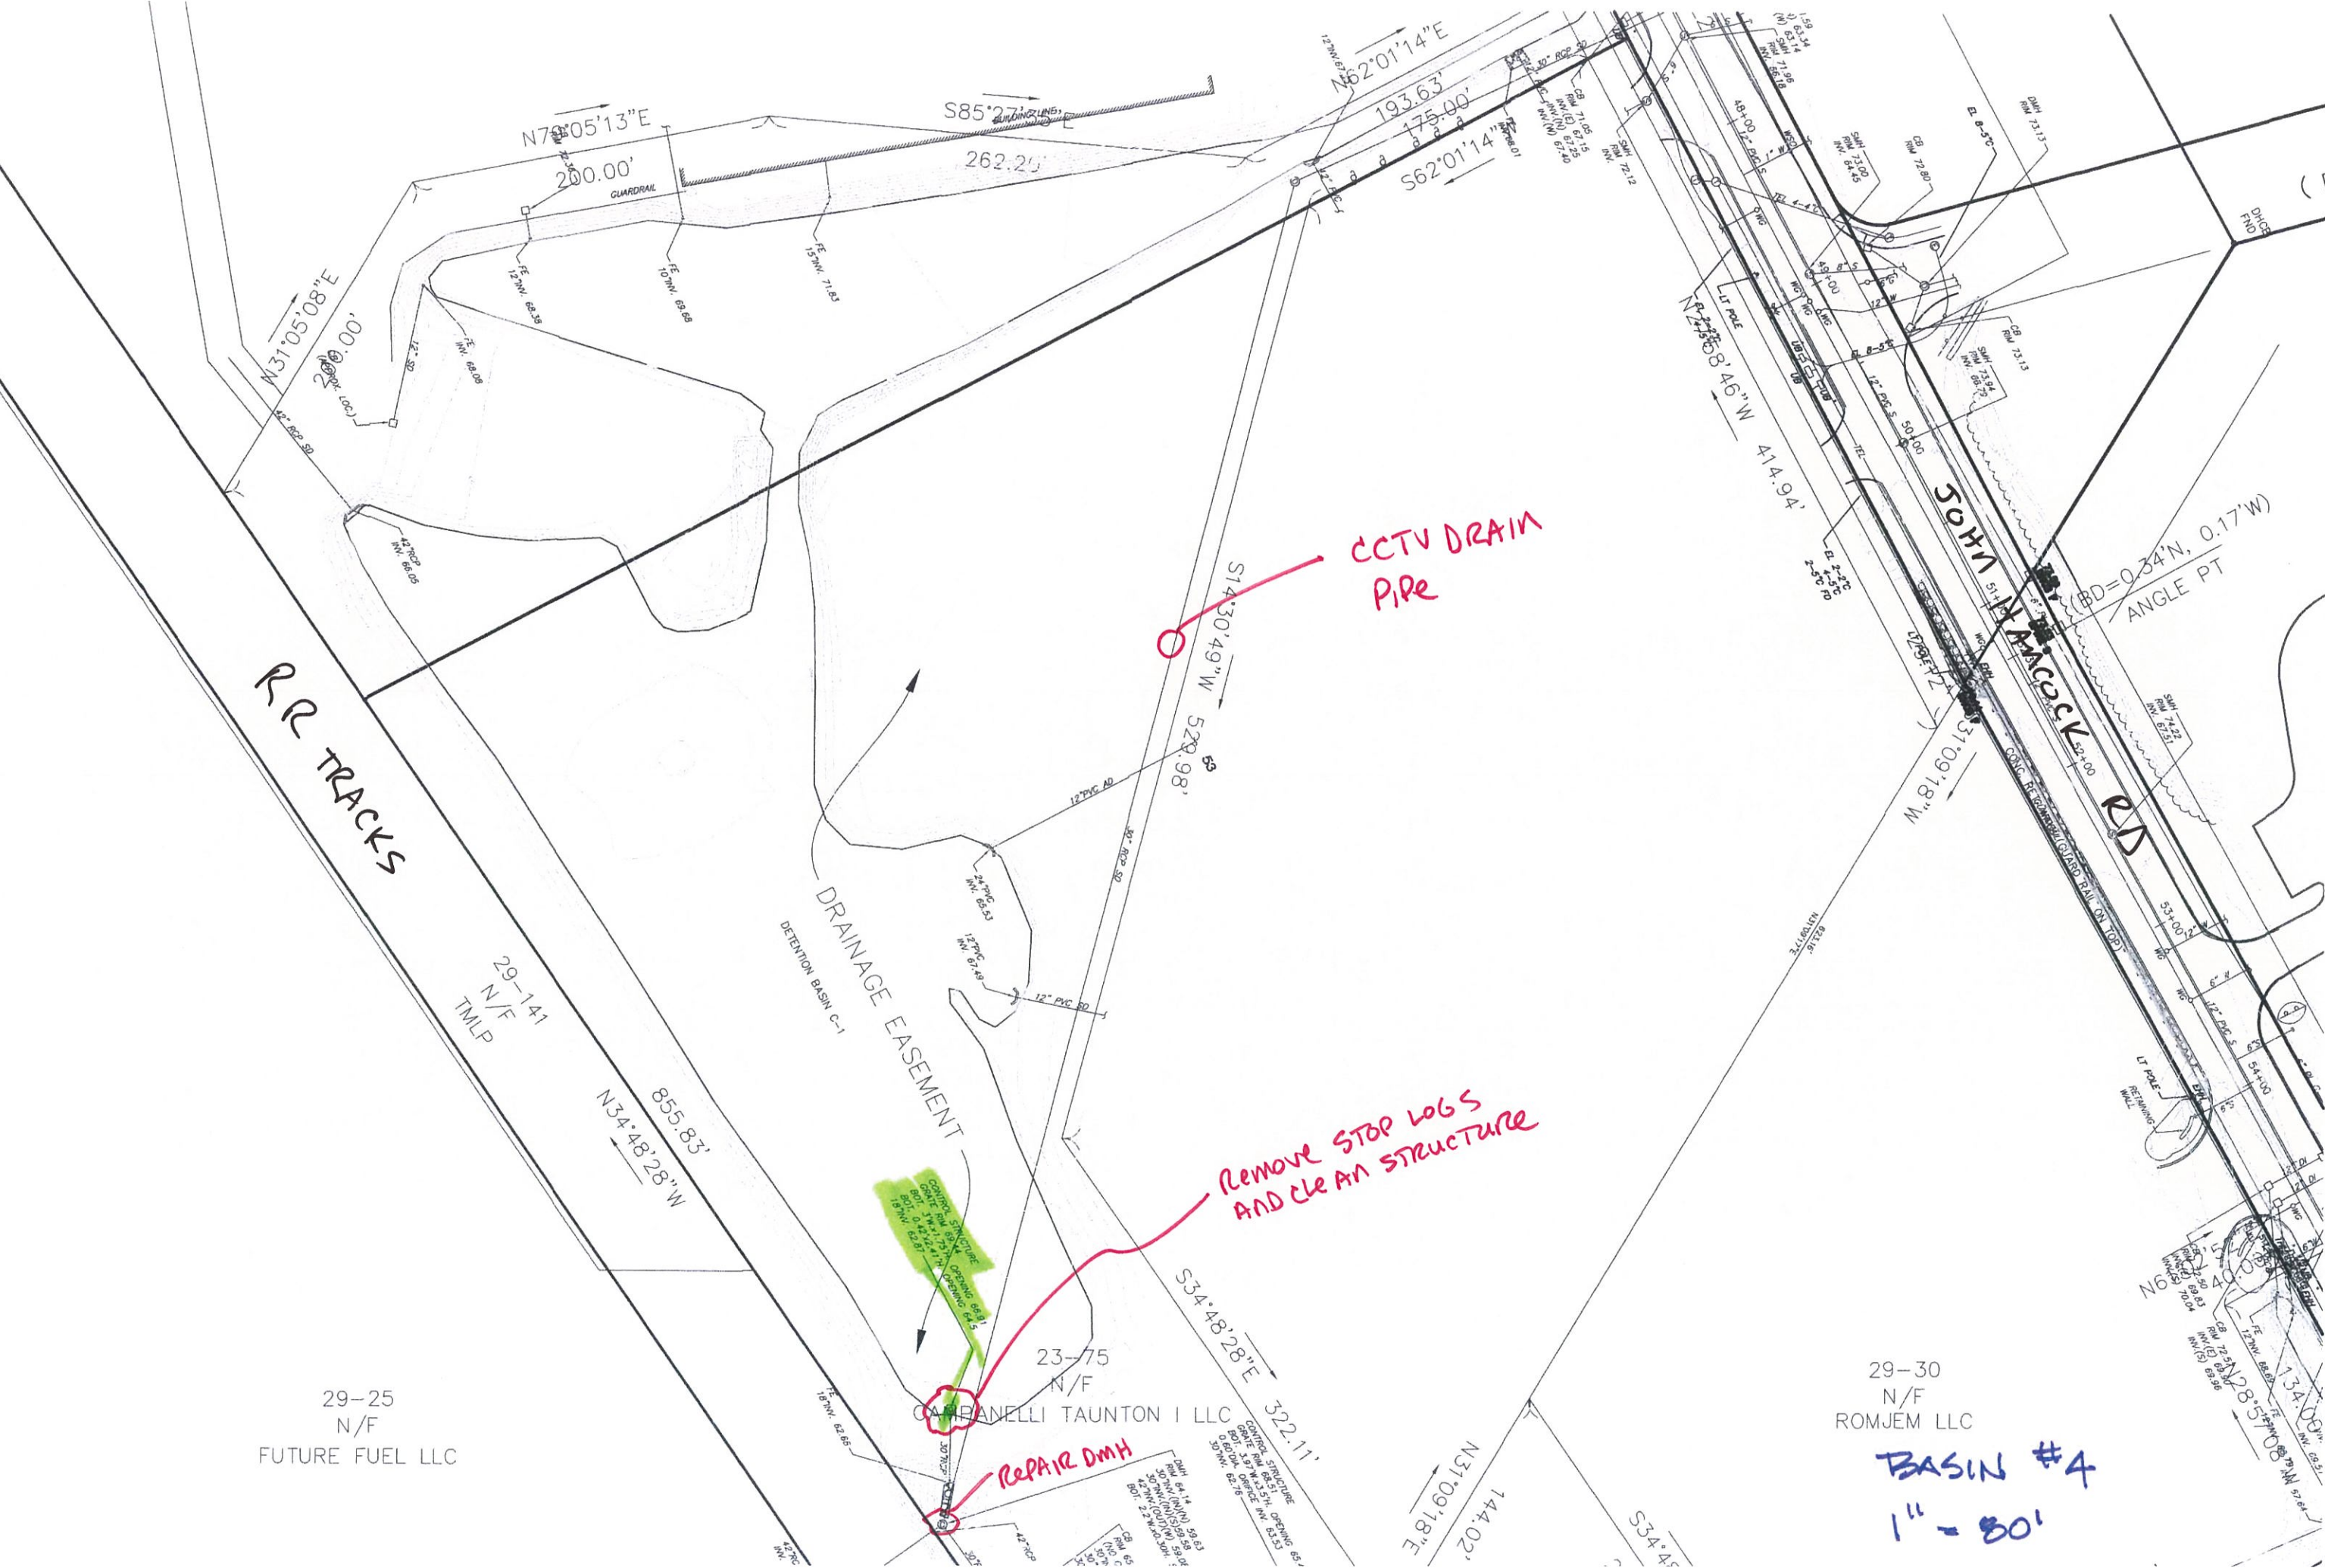
29-30  
N/F  
ROMJEM LLC  
BASIN #4  
1" = 80'

- IV. Basin #4 (John Hancock Rd)
  - A. Pipes under driveways on West Side of Hancock all plugged with soil and mulch, system needs cleaning to get flow into Basin #4

- B. Headwall at outlet of Basin #4 needs cleaning of trash, brush, and debris.
  - C. Remove stop logs from control structure from Basin #4
  - D. Drain structures at outlet of Basin #4 (near RR tracks) need cleaning repair

- E. Investigate condition of drain pipe between John Hancock Rd and Basin #4
- V. Basin #5
  - A. No work needed
- VI. Prince Henry Drive (#6A & 6B)

CCTV DRAIN PIPE

REMOVE STOP LOGS AND CLEAN STRUCTURE

REPAIR DMH
